# ASSESSMENT OF SEISMIC RISK AT KONKOLA MINE – No 1 SHAFT

Alfred Mutale  
Geotechnical Engineer -Konkola Copper Mines Plc

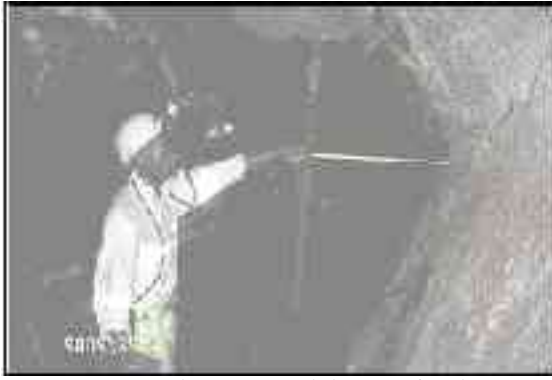
In drives, the rock burst type of ground damage is observed to come mostly from the top eastern corner, as indicated in figure 1 and 2, and midway between the roof and the floor of the crosscuts. The depth of damage is up to 4m. Very little damage, if any, is experienced in the western part of the roof and in the western sidewalls. Sometimes, stress induced fracturing of ground is observed in the eastern sidewall.

A bedding plane usually bounds the surface in the top part of the failure zone. In the eastern most corner of the failure zone, the surface is frequently conchoidal (rough) and curved; refer to figure 1 and 2. The bottom part of the rock failure zone is also usually a conchoidal curved surface.

Figure 1. Picture showing ground damage after the occurrence of a seismic event

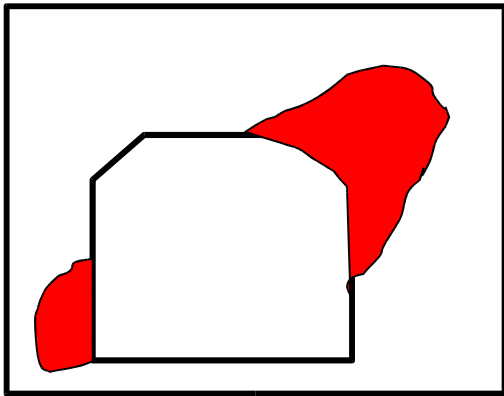
Overall, the shape seen in drives damaged by seismic events is that of a “dog-ear”, as can be seen in figures 1 and 2. The same shape is seen in most drives in other high stress areas that do not experience seismic events. The shape suggests rock failure in compression by a principal stress in a direction sub-perpendicular to the failure zone that is from the top western side and dipping towards the east. It has been observed that areas that experience rockbursts always undergo high stress type sloughing of rocks for some time before a rockburst occurs. This means that seismic events occur only in high stress areas.

Figure 2. Shows a “dog-ear” shape damaged zone after a rock burst

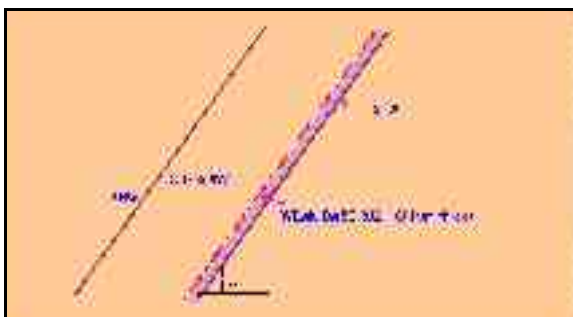
Figure 7. Weak base “unit A” of the ore shale is absent in the seismically active areas of Konkola Mine – No 1 Shaft

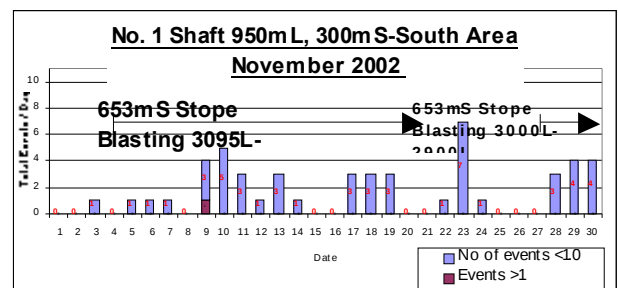
Figure 8. Shows an increase in seismic activity during stopping operations, as stope ring blasting approaches the crown pillar, increase in seismicity is noted due to increased stress concentrations in the pillar.

- Current mining practice in seismic prone areas reveals that support is installed late thus, allowing smaller magnitude events to weaken the rock mass leading to shakedown events. Stope face configuration during ore extraction also leads to high stress concentrations in crown pillars, as observed in figure 8.
