# **Weak Floors and their Influence on Pillar Stability in Southern African Collieries**

J W Latilla  
Ingwe Collieries, Rock Engineering Department

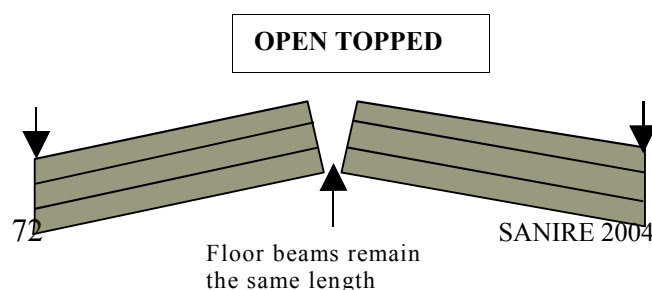
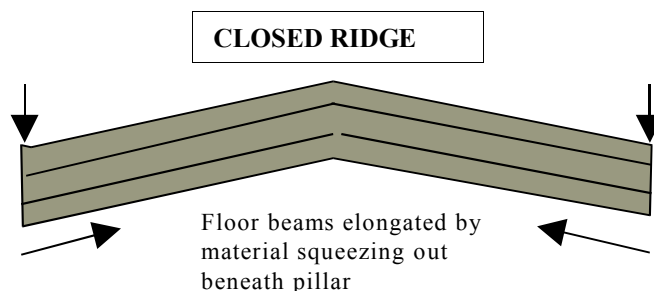
**Figure 1. Open and closed ridge floor failure types**

The case study floor failures have been classified as type I, II or “Newcastle”, according to Peng, Wang and Tsang (1995) or Seedsman and Gordon (1991). Type I floor heave is open topped, indicating that the failed floor beams remain the same length, in other words they do not extrude from beneath the pillars (Figure 1). Type II heave is of the closed ridge form and results from weak material flowing from beneath the pillars (Figure 1). “Newcastle” type floor heave has as its central mechanism the shearing of the floor within a 1 to 2m wide “rib spall zone” around the edge of the pillars.

The soft sandy shale floor was further weakened by water and dykes as well as (possibly) the underlying dolerite sill. This weak floor material was then squeezed out from beneath the harder coal pillars. The floor damage has been classified as “closed ridge” type heave (Figure 1).

The immediate floor, consisting of 2m laminated sandstone and shale, was not capable of supporting the additional pillar load and started to flow out from beneath the pillar resulting in “closed ridge” type floor heave (Figure 1). Subsequently severe floor heave and accelerated pillar spalling occurred.

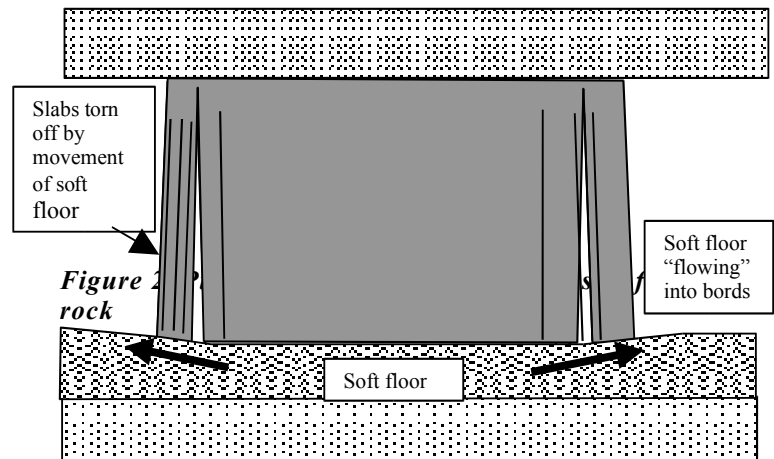
As the pillars were only 5.1m wide the effect of 200mm to 500mm wide slabs being torn off is significant (Figure 2). This was caused by the pillar foundations flowing into the bords (Jack and Madden, 1995). In the worst case, this would leave pillars with an effective width of only 4.1m. The resultant safety factor and width to height ratio of the reduced pillars would have been 1.3 and 1.7 respectively.
