## APPLICATION OF A THIN SPRAYED LINER (TSL) IN VCR GULLIES BEHIND ADVANCING STOPE PANELS AT SAVUKA GOLD MINE

R. Carstens, A.O. Oosthuizen  
AngloGold Ashanti

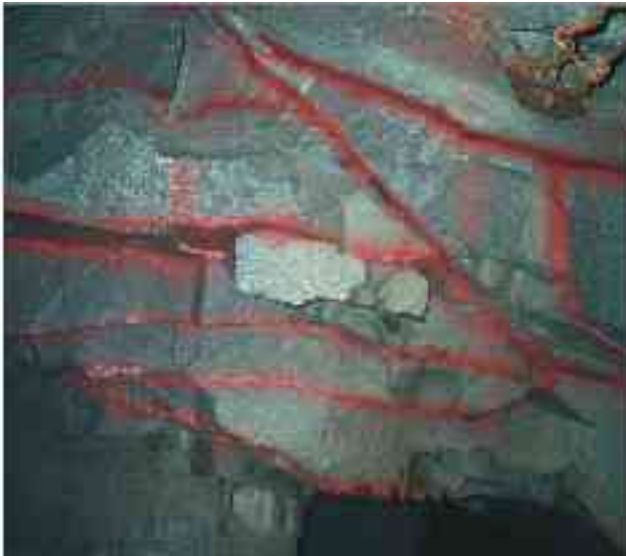
The immediate hangingwall and footwall consists of Alberton lava and Elsburg quartzite respectively. Alberton lava is normally very competent with a Uniaxial Compressive Strength (UCS) of 268 MPa in general. Elsburg quartzite has a UCS of 282 MPa. Two major joint sets intersect the area striking west-southwest and north south. A number of flow planes are present further reducing the competency of the lava hangingwall. Photo 1 illustrates the condition of the hangingwall in W1 gully. Calcite veining is present on joints and flow planes reducing the cohesion on these planes.

**Photo 1:** Condition of W1 gully hangingwall.

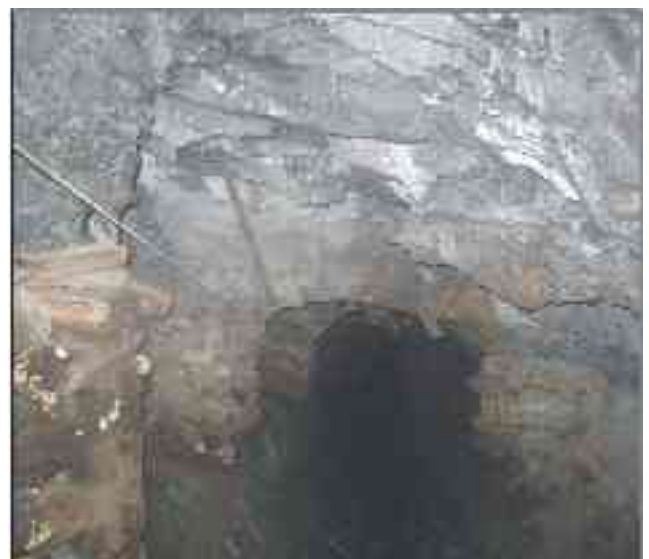
**Photo 2:** Condition of W1 gully hangingwall before application of TSL.

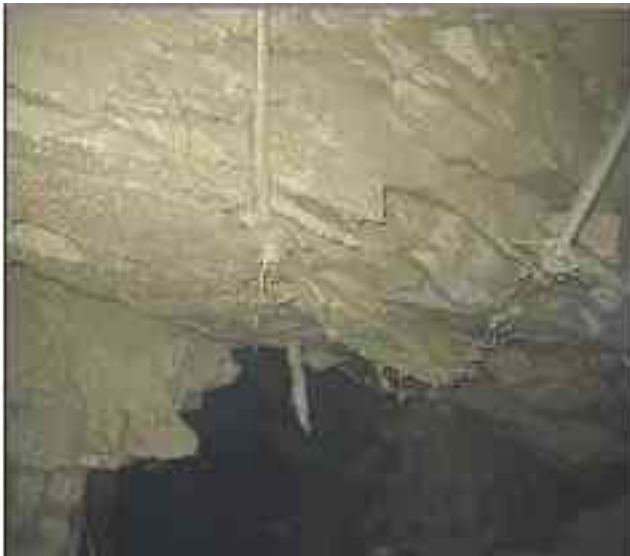
Initial testing was conducted in the back area of 70/31 W1 gully where the hangingwall conditions had deteriorated extensively. A total of 86m of backlog spraying were done. The gully hangingwall inclusive of the areas between gully pack support above and below the gully was sprayed. Following application of the TSL no further time dependant deterioration and unravelling of the hangingwall was observed over a 5-month period.

**Photo 3:** Condition of W1 gully hangingwall following application of TSL.

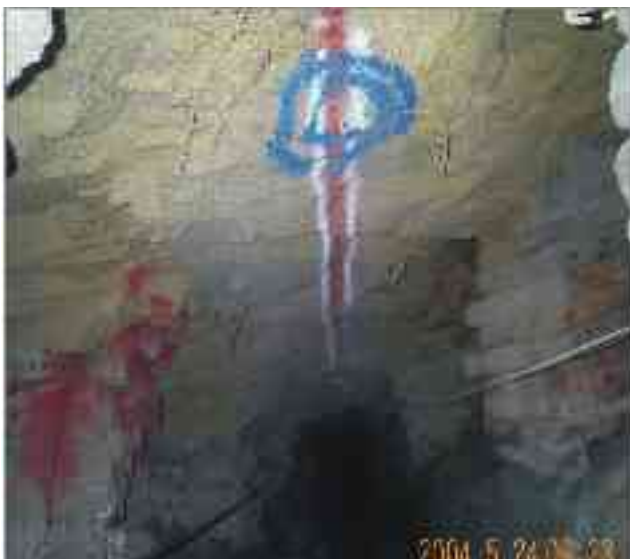
**Photo 4:** Condition of W1 gully hangingwall following application of TSL close to advancing stope face.

During the second phase of the testing the TSL was kept close behind the advancing mining faces. Again the gully hangingwall inclusive of the areas between the gully pack support were sprayed. In general the TSL was kept within 10m of the gully face position. Three gullies were sprayed and there was a significant improvement in the ground conditions.

Photo 4 illustrates the condition of the W1 gully where the TSL was applied close to the advancing faces.

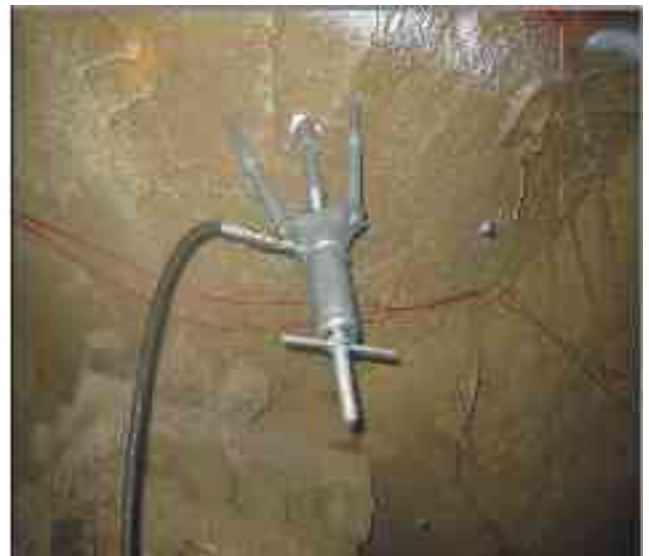
Bond strength tests were conducted by Indy Rock as part of a larger SIMRAC project SIM 02 02 06 on TSL's. A small disk (39mm dia.) is glued to the TSL with an epoxy and left for 24 hours to cure. On the following shift the TSL is scored in a square 50mm x 80mm to define the maximum extent of TSL that can be removed and pulled off with a hydraulic pull tester. In total 17 tests were conducted in W1 gully. Photo 5 shows how the pull test is conducted.

The average bond strength was 1.44 MPa with a standard deviation of 0.71 MPa.

**Photo 5:** Pull tester used to determine in-situ bond strengths.

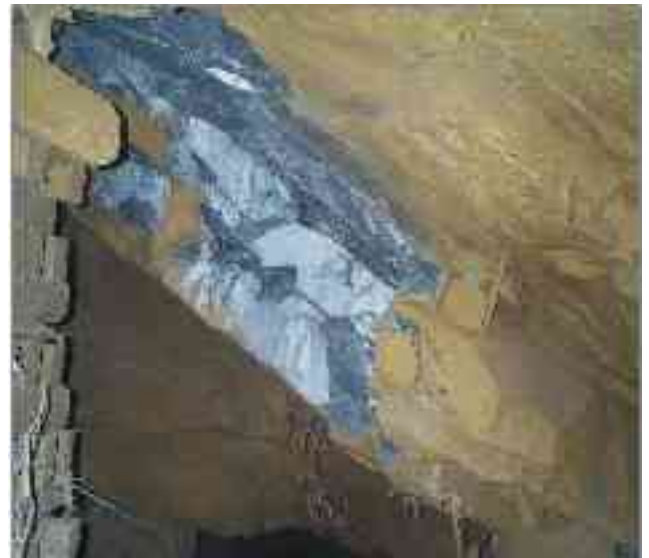
On 31 March a seismic event with magnitude 1,5 caused rockburst damage in the W1 gully. The damage was in the form of shakedown from the face of a brow and a portion of the hangingwall. Following the event the area was re-sprayed and no further deterioration was observed to date. One can only speculate whether the TSL reduced the severity of the rockburst damage.

**Photo 6:** Rockburst damage caused to a brow in the W1 gully.

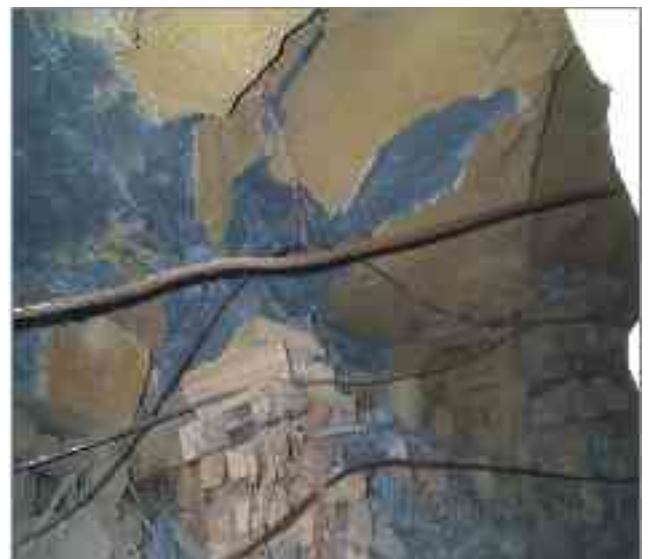
**Photo 7:** Rockburst damage caused to hangingwall of the W1 gully next to a strike stabilizing pillar.
