# Partial Extraction of Local Support Pillars in the 106 S4 Region of Cooke 3 Shaft, Harmony's Randfontein Operation: A Case Study

<sup>a</sup>Brentley Lucas and Associates (Pty) Ltd Mining consultants

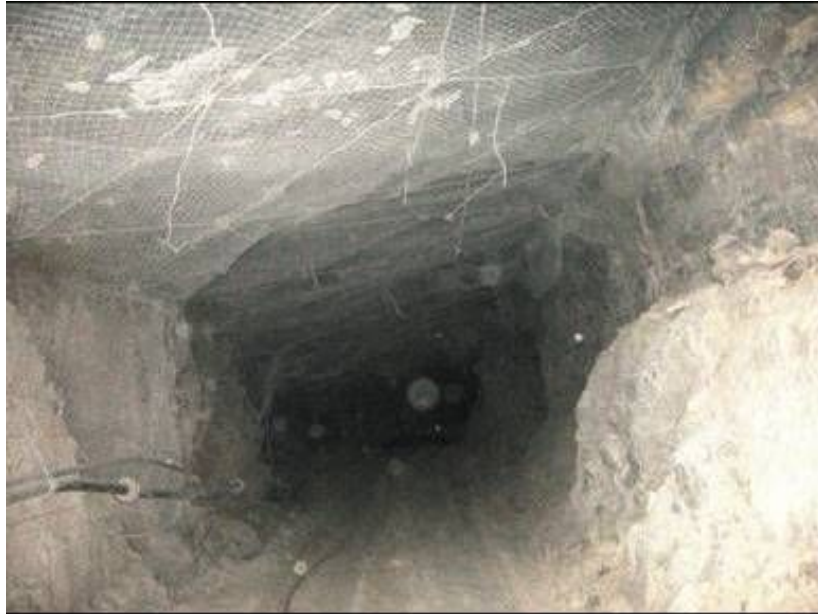
**Figure 2. Mesh and lace used in parts of the access roadway**

- The access roadway was originally supported with 25mm diameter x 2.4m pre-tensioned resin grouted rebars on a 1m x 1m square pattern with mesh and lace in places where conditions required it.
- The access roadway was serviceable; however in places the height of the roadway exceeded 7m, and required costly and time consuming re-supporting.
- Where the roadway passed through a fault loss abutment, the roadway sidewalls appeared to be highly stressed with sidewall spalling. In addition to the rebar, 4.5m x 20t cable anchors were installed in the hangingwall on a 2m diamond pattern.

Figure 2 shows mesh and lace installed in a portion of the access roadway when it was originally developed.

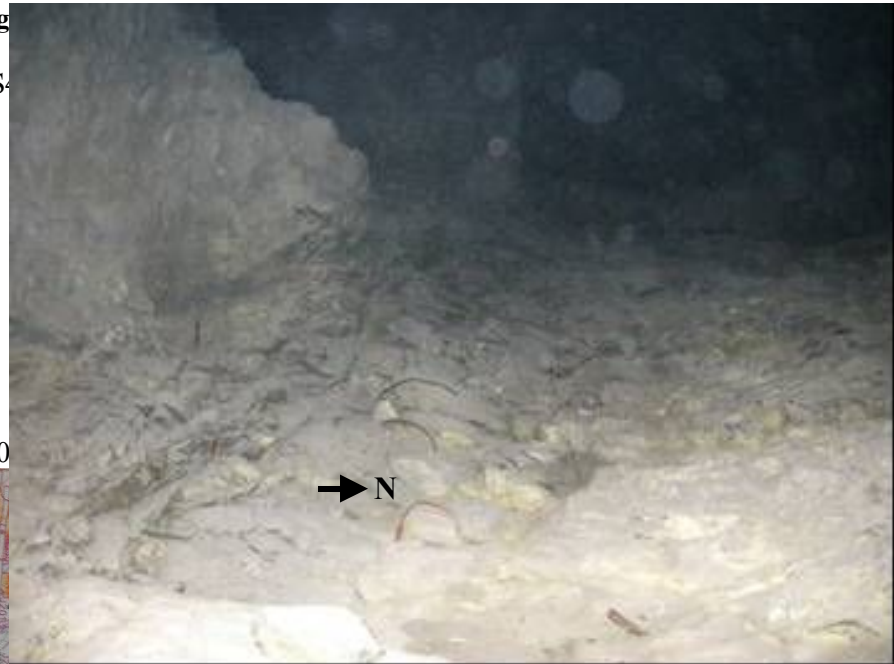
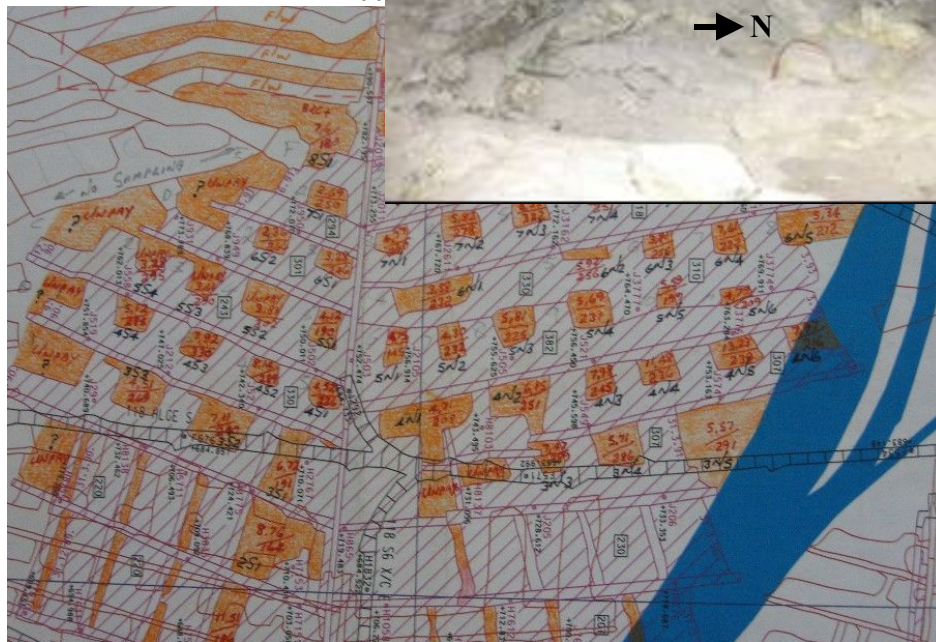
**Figure 4. S4 Pillars on the A5 reef before phase 2 mining**

- All the pillars appeared to be in a stable condition with no evidence of scaling.
- Originally the extraction ratio was 76% with average pillar dimensions of 10m x 8m. The proposed extraction plan would increase the ratio to 82%.

Figure 4 shows a plan view of the S4 as follows:

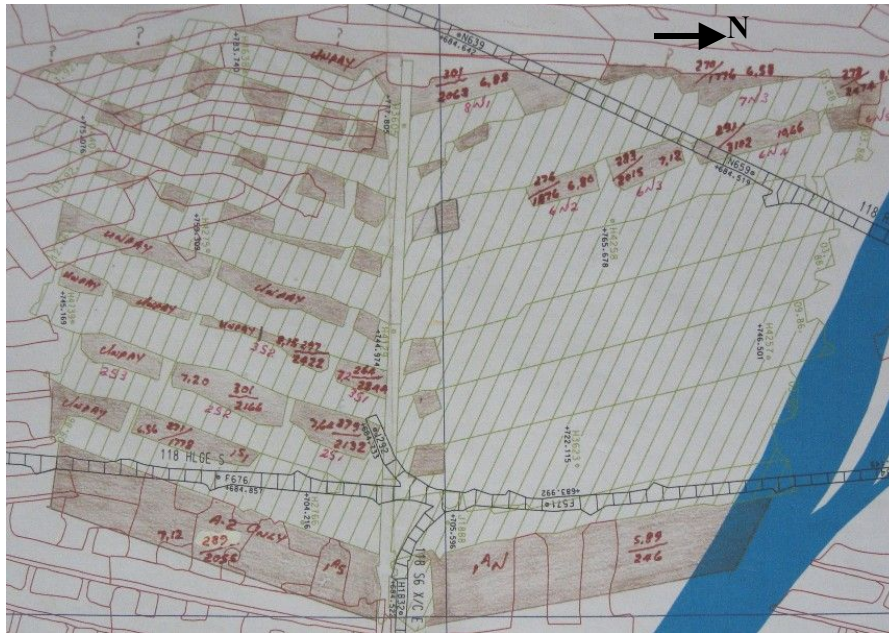
Figure 5. The A2 reef below the A5s. Crush pillars left on the A2 reef are shown

The pre-extracted A2 reef which lies directly below the S4 pillars is shown in Figure 5. The middling between the two reefs is, on average 17m varying from only 2m on the south west side to more than 30m in the east. The outline of the initial A5 roadway development is indicated in red.

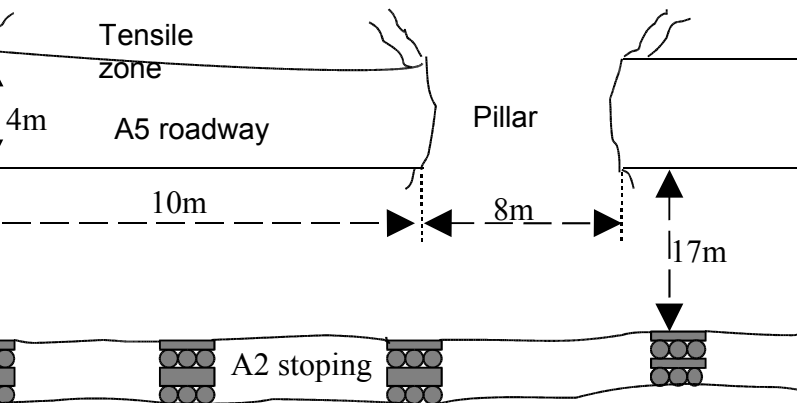
Figure 7. Roadway, pillar and middling dimensions

A Cross sectional view showing the dimensions of the pillar mining area is presented in Figure 7. The hangingwall and footwall of the A5 consists of massive competent quartzites. Laboratory testing has indicated a UCS of between 240 MPa and 310 MPa for both the A5 reef and the hangingwall rock.

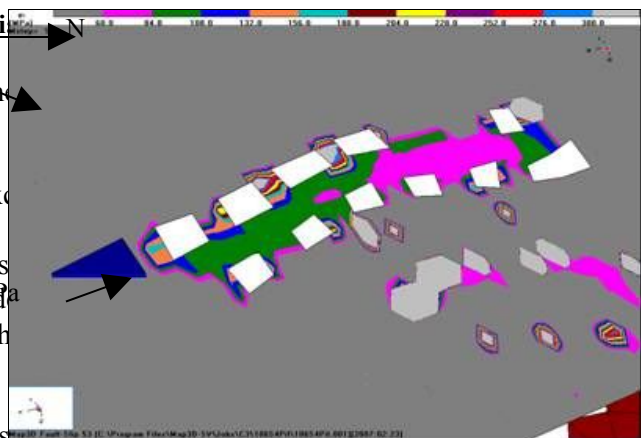
Figure 8. State of stress in the pillars and immediate hangingwall

Figure 8 shows the state of stress in the roadway pillars prior to any mining. The model shows that the pillars on the West side of the roadway were already subjected to loads of more than 300 MPa. Also shown in Figure 8 is the state of stress in the remnant pillars on the down-dip east side of the roadway. The blank areas indicate mined out portions.

- The pillars on the west side of the roadway have failed.
- Sequential mining of the pillars shows that all their UCS values will be exceeded.
- A further physical examination of each pillar to assess the following:
  - The condition of the pillar
  - The presence of discontinuities
  - Cracks in the hangingwall and footwall next to each pillar, indicating possible pillar punching
- The pillars should be only partially extracted. Complete extraction of the pillar might result in failure of the crown above the pillar.
- The final dimension of the pillar should not be less than 4m by 6m on plan.
- The pillars should be extracted on a retreat basis from the South to the North with the Southern most pillar left intact.
- Not every pillar should be mined, at-least every third pillar should be left intact to create a barrier against regional collapse.

- The area should be treated as a special area, and special area precautions applied at all times.
- The type of explosives used should cause minimal damage to the hangingwall.
- Pre-conditioning should be applied to all pillars where more than one blast will be taken.
- A mechanical scaler should be used to prepare the face of each pillar prior to the commencement of drilling operations as they may be highly stressed.
- Netting should be placed against the pillars prior to drilling to protect the drilling crews from spitting rock.
- Cleaning and vamping should be kept up to date, minimizing the time exposure of men and machinery to potentially unstable ground conditions.

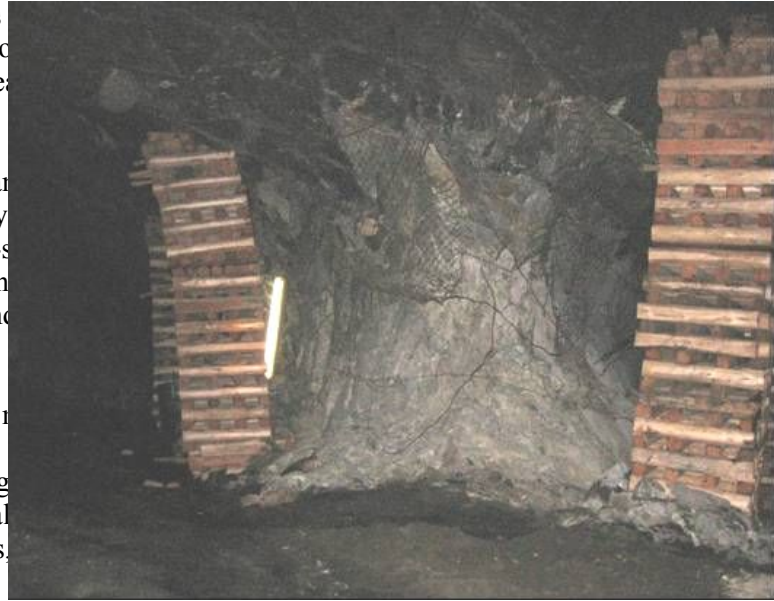
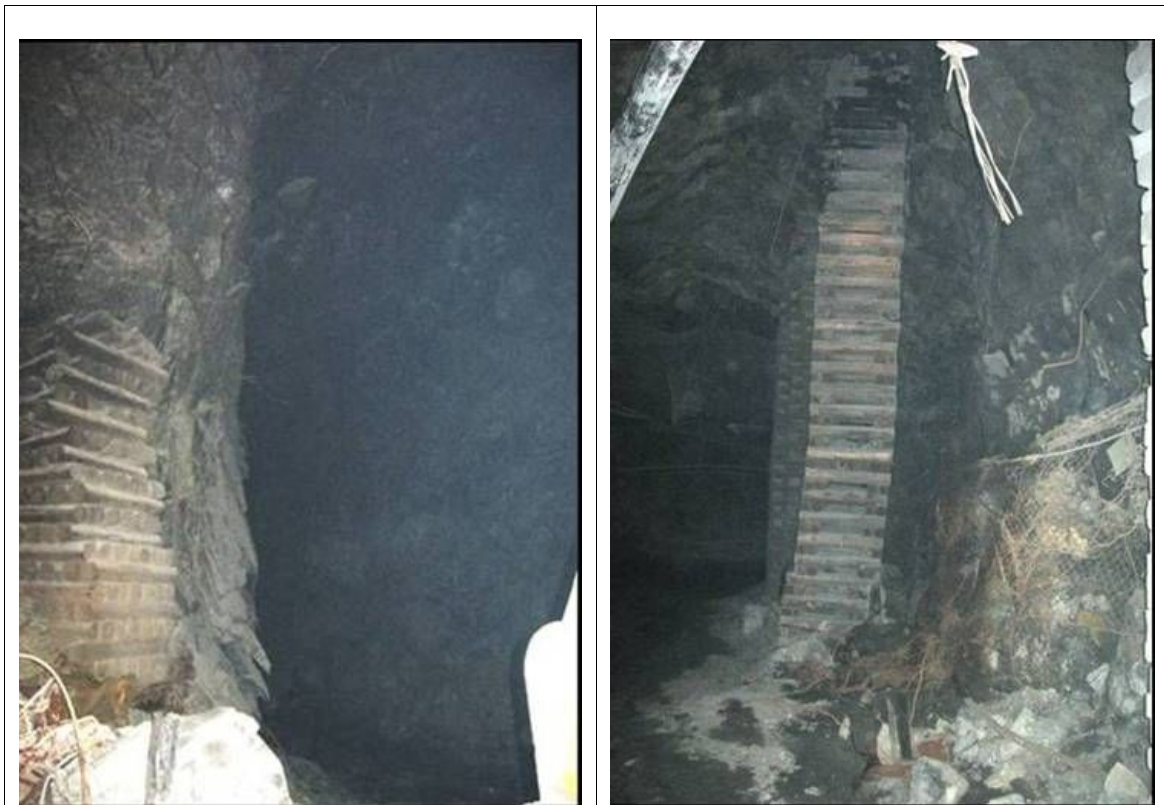
A hangingwall fall of ground in a roadway can common method of re-supporting high roadway a dozer to provide a platform from which re-s becomes impracticable when the hangingwall h in this area would be costly, time consuming and

The most practicable method of supporting Although these packs cannot possibly provide successfully arrested further falls of ground mechanism by which they secure the hanging preventing further unraveling of the hangingwall Figure 12. After the installation of these packs during the pillar mining operations.

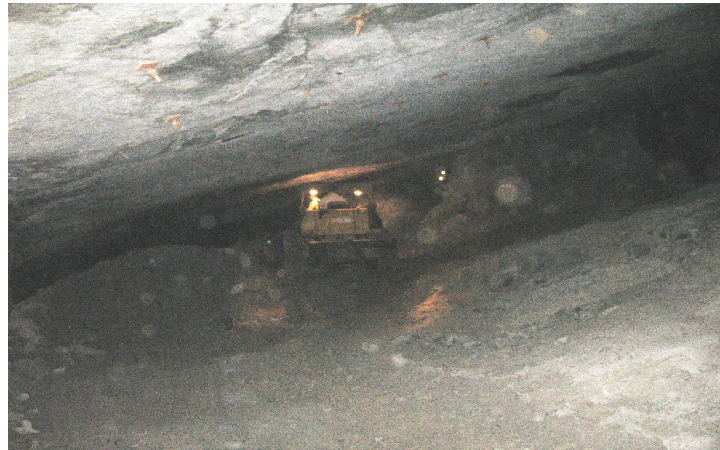
**Figure 12. A dozer operating in a 12m wide roadway**

Figure 13 shows a dozer pushing up a rock pile for the loader; here pillar mining has increased the span to 12m. Although the hangingwall remains intact, there is evidence of new cracks appearing along the axis of the roadway.

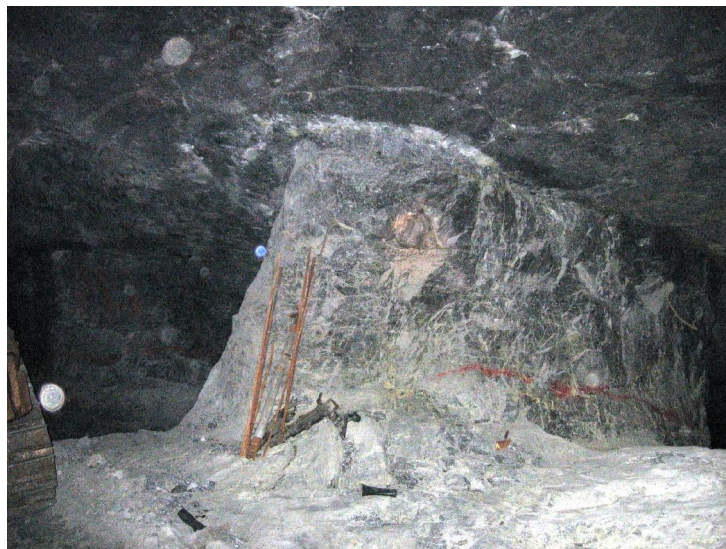
**Figure 13. 3.5m high 4m x 6m pillar**

The two 4m x 6m pillars left after the 12m x 8m pillar was cut, were usually found to be in good condition with no evidence of scaling in the initial stages. It was anticipated that the under-stoping would result in footwall punching; however, this did not occur. Figure 14 shows a newly cut 4m x 6m pillar with no evidence of scaling, however, vertical fracturing, which formed in the hangingwall around the perimeter of the pillar shows early evidence of failure.

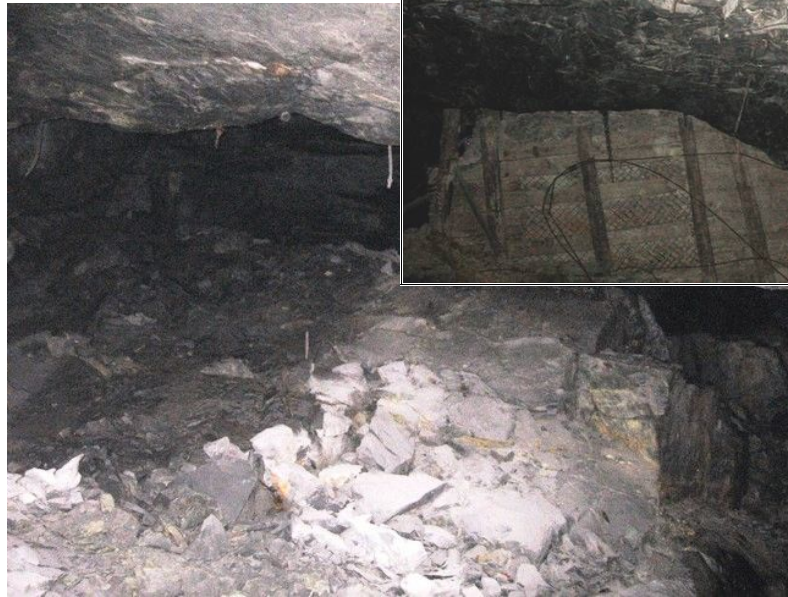
**Figure 15. FOG 5m x 10m 1.5 m high with solid pieces of hangingwall**

Figure 16 shows a large fall of ground that occurred during the mining operation where the roadway span had been increased. This occurred a month after the area had been barricaded.

Large falls of ground did occur in the abandoned back areas indicating time dependent behavior of the rock.

- Increasing the span of the pillar mining roadways from 10m to 12m resulted in large falls of ground between pillars.
- All falls of ground appear to be bounded by steep dipping fractures, which formed next to the pillars, and shallow dipping curved fractures originating from adjacent pillars 1m to 4m in the hangingwall.
- Where falls of ground did occur, generally a time delay of between 1 month and 3 months was noticed between when the pillars were reduced and the fallout occurred.
