# Back Analysis of Rockburst Damage To Verify Assumed Design Parameters

Lucille Cilliers & Koos Bosman

# Buffelsfontein Gold Mine

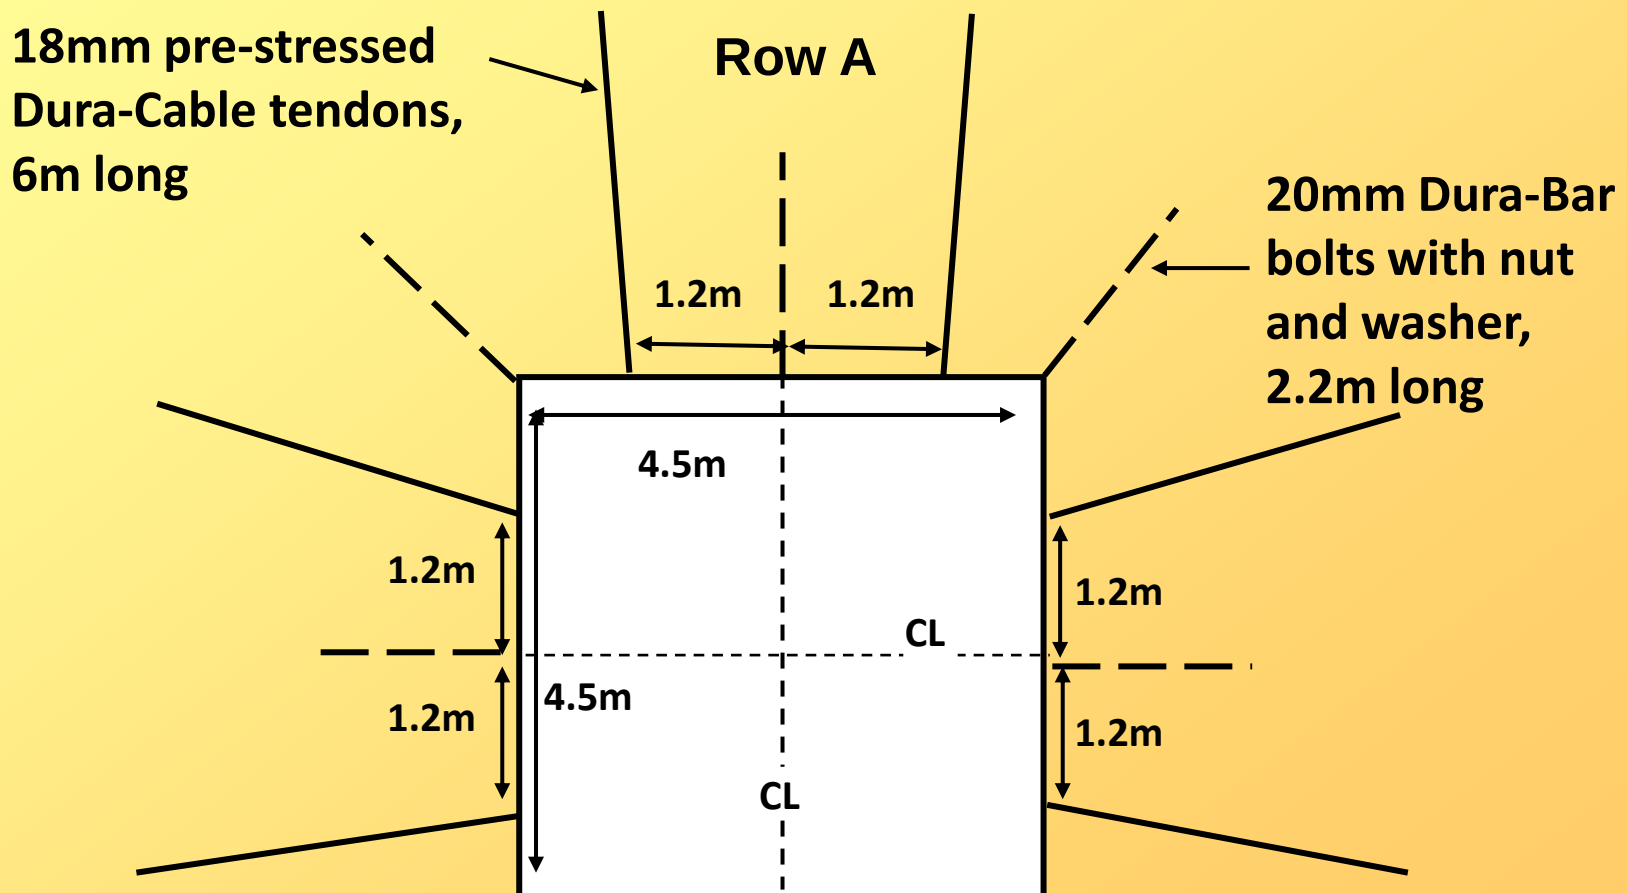
# Tendon support pattern

Row A and B support patterns to be alternated every 1m

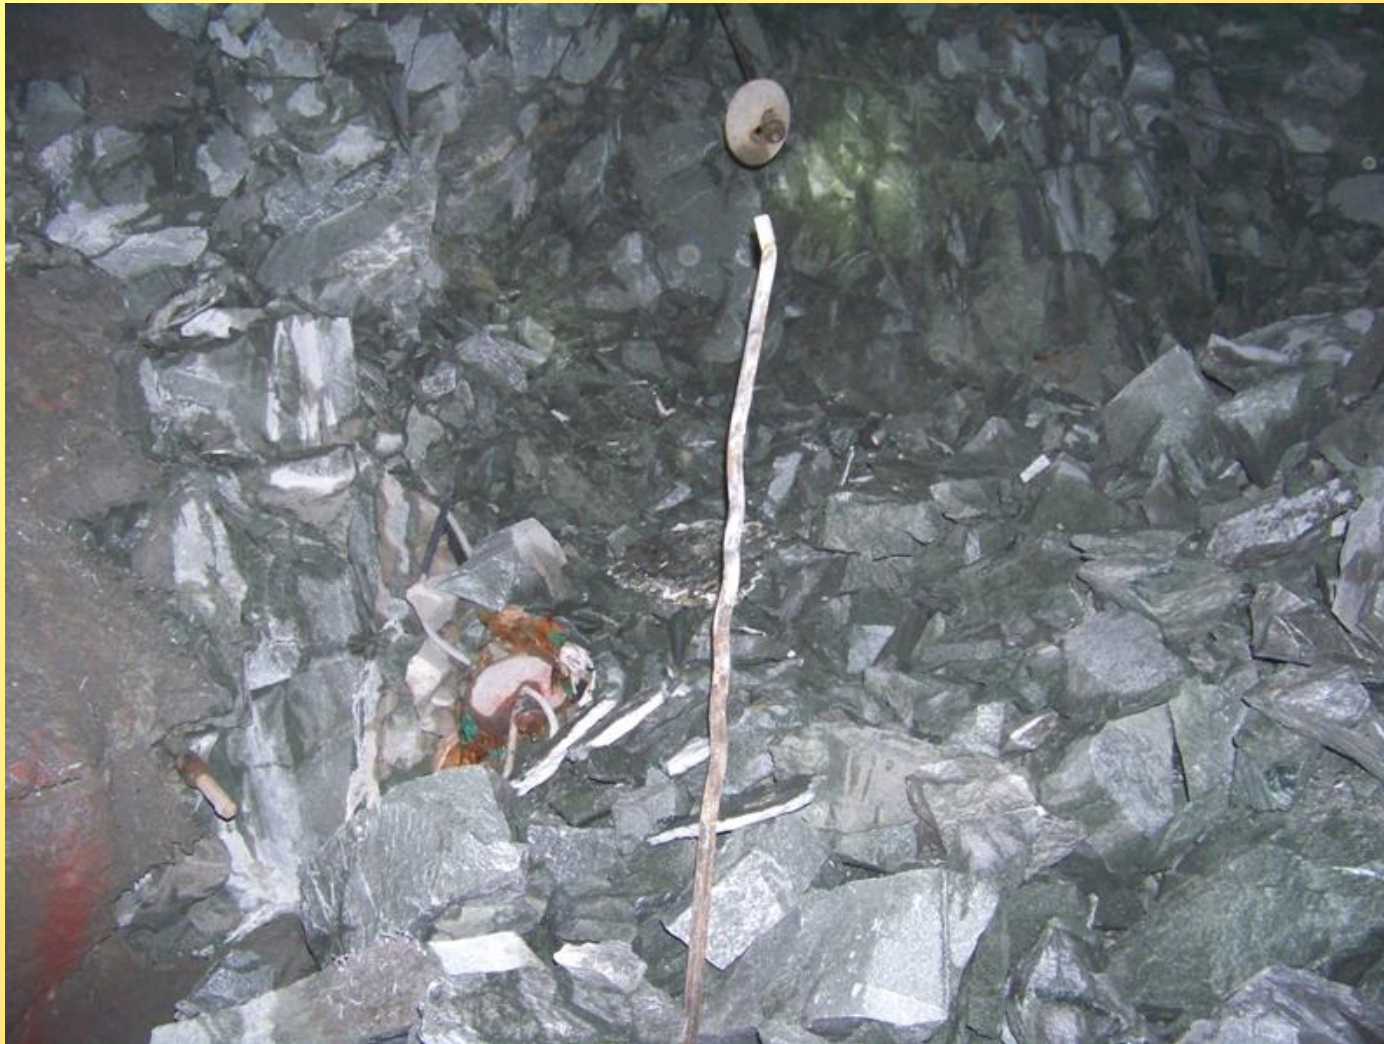
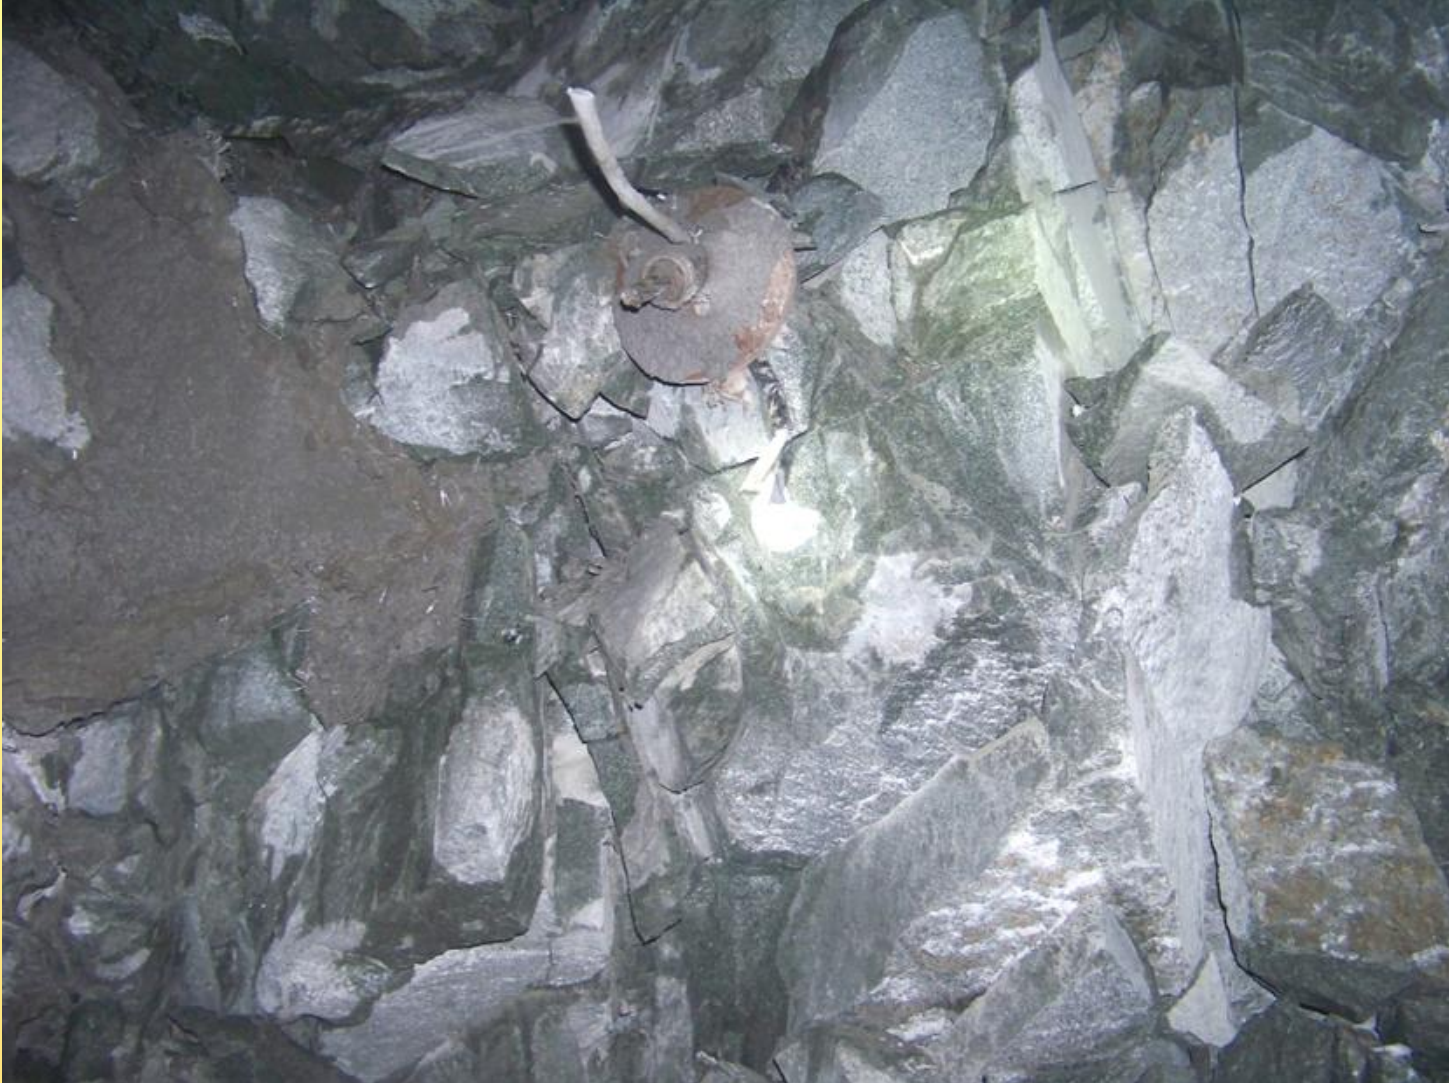
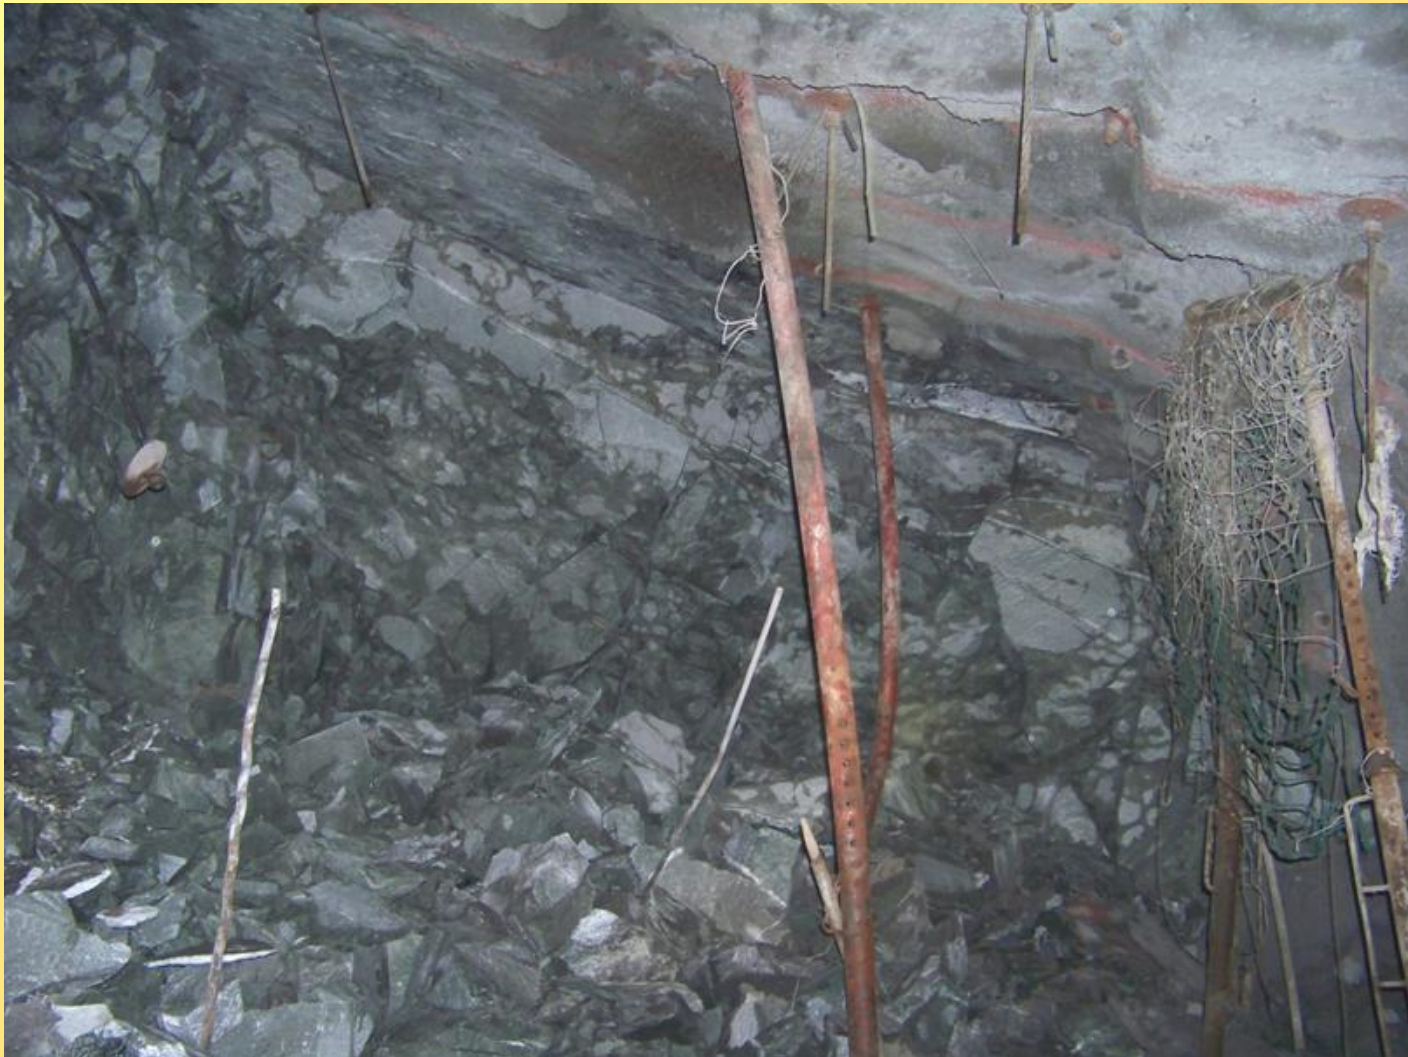
20 May 2009 – Magnitude 0.5 event

# Damage to tendon support

- Ejection volume together with Durabar was estimated to be  $1 \times 1.2 \times 0.5\text{m}$
- At  $26.98\text{kJ/m}^2$  for Durabar, the required velocity =  $5.66\text{m/s}$
- The combined system @ an ejection velocity of  $5.66\text{m/s}$  is capable to accommodate  $1.1\text{m}$  ejection thickness.

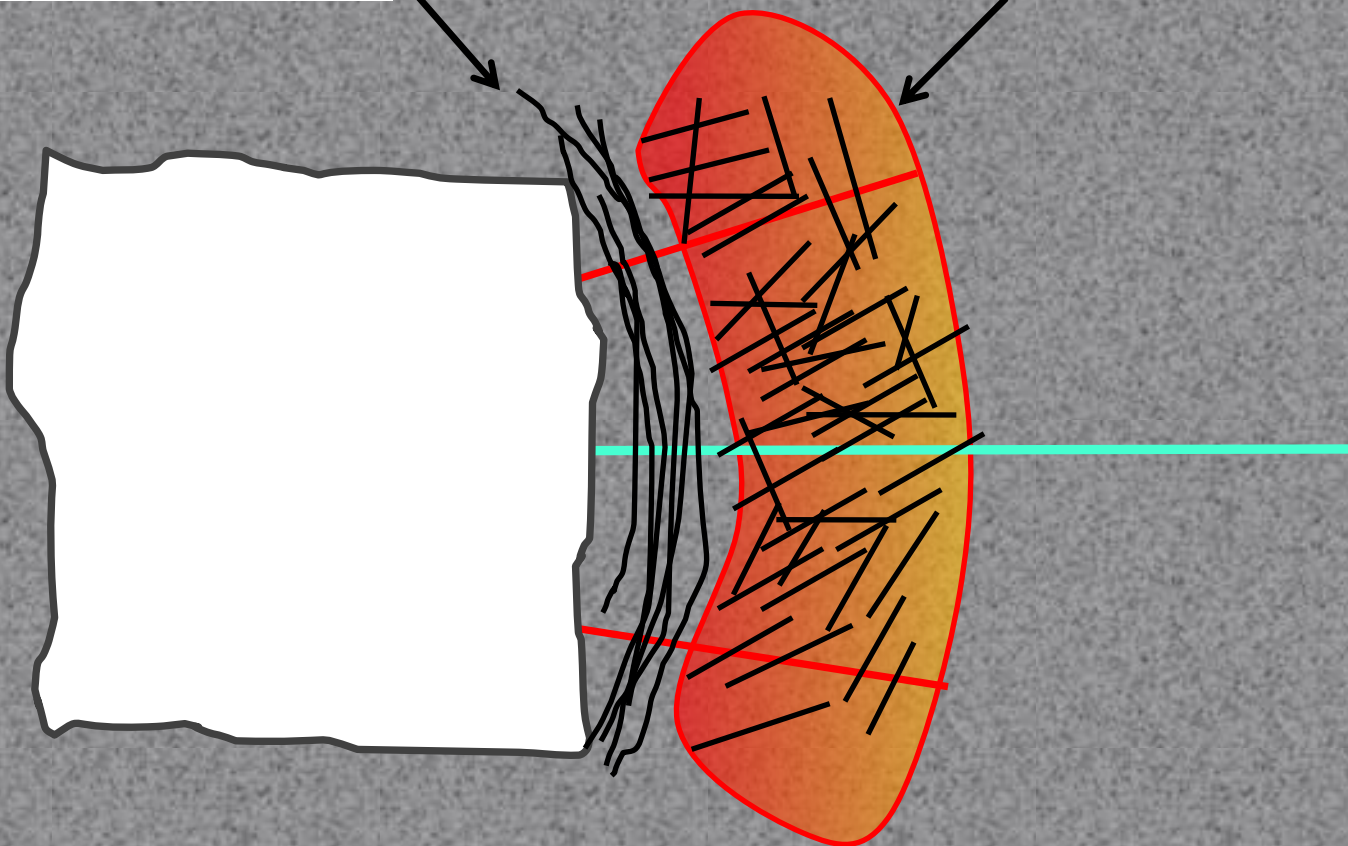
# Failure mechanism

Fractured zone  
around excavation

Burst fractures  
between tendons

- The tendon support system is adequate in terms of energy absorption capacity.
- The tendon support system alone is inadequate, under these specific rockburst conditions, to contain damage.
- Damage was controlled by brittle nature of the rock mass and the ineffectiveness of the containment support.
- The observed damage suggest a lack of interaction between individual units within the system.
