# **Rock Engineering Department**

## **Project Report**

## **Characterizing rock mass behavior in terms of fracture formation using micro seismic monitoring: Preliminary project report**

**SANIRE Symposium 2013**

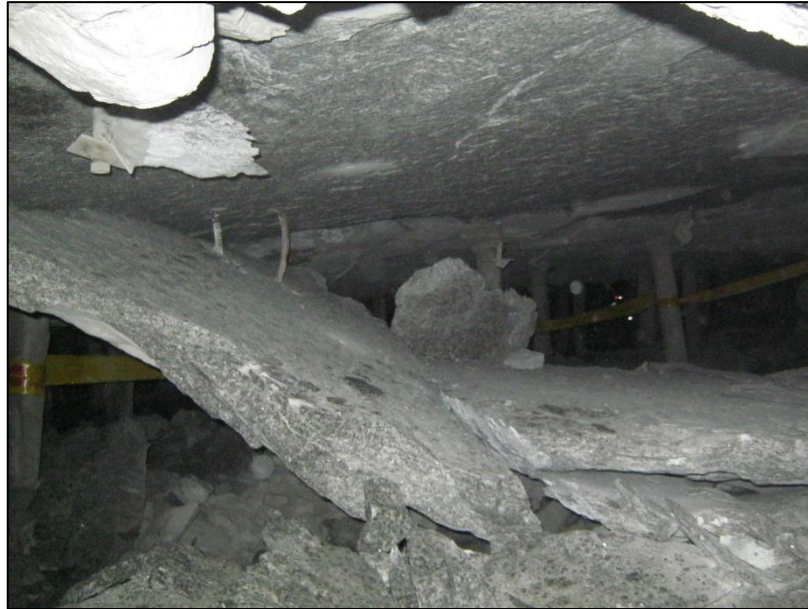
**Figure 3: 8mW28W2 Note the smooth, flat fracture plane**

As stated previously the falls that occurred in the 8 level west area had some evidence of stress related damage. The following series of photographs illustrate the typical failures encountered.

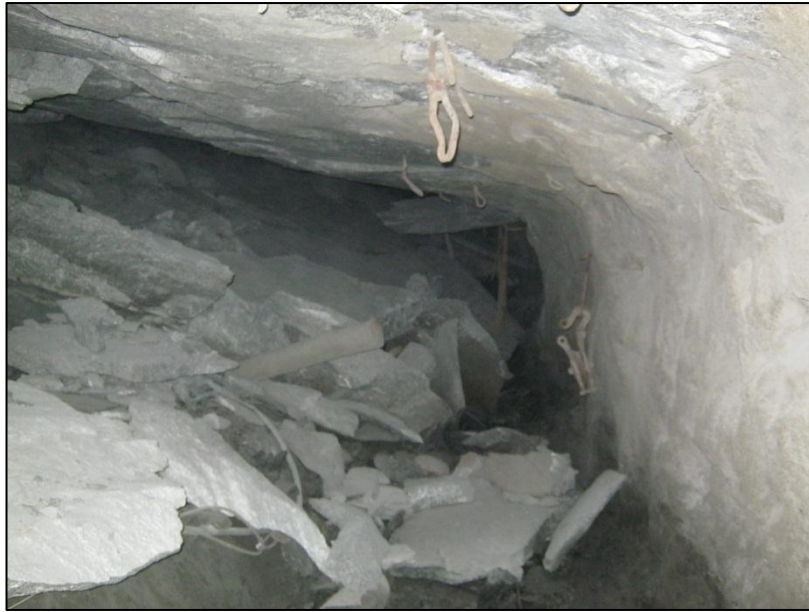
**Figure 5: View along the ASG**

The following series of photographs were taken approximately one week prior to the collapse shown in figure 5 above.

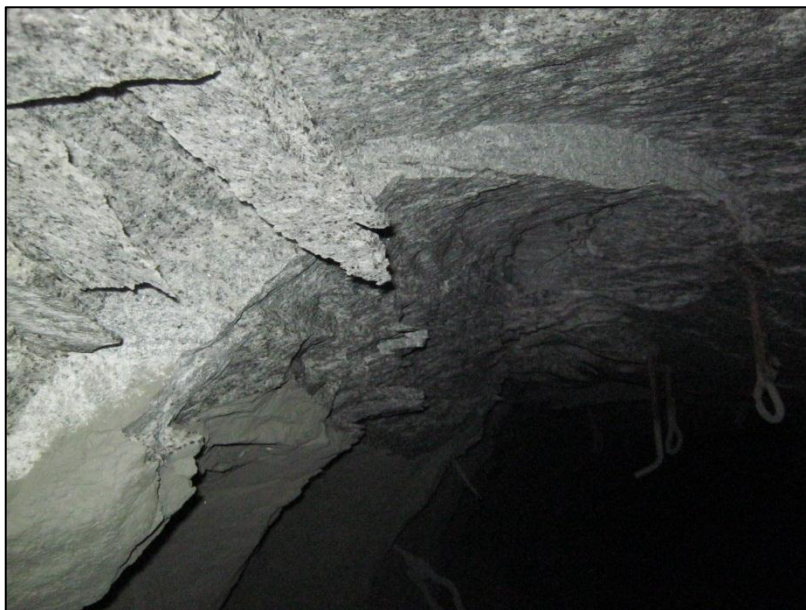
**Figure 8: Scaling at the pillar/ASG interface**

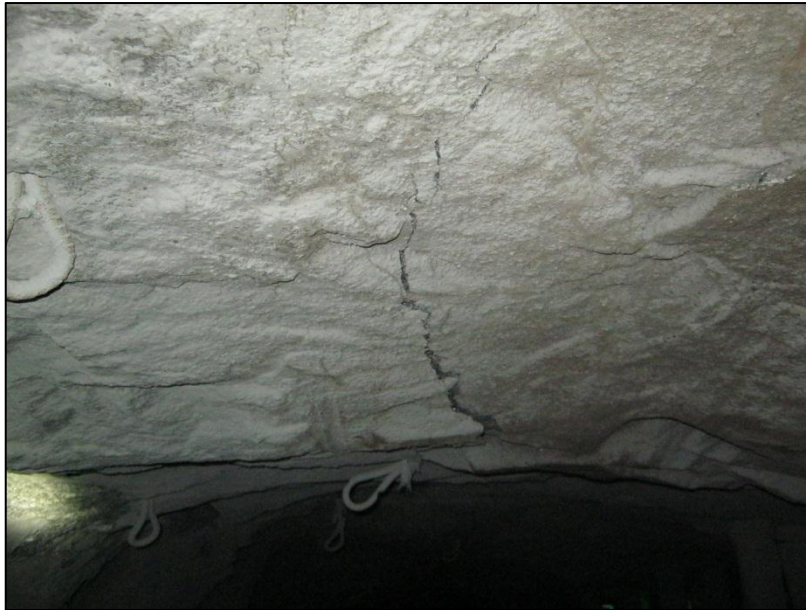
**Figure 9: Open fracture in the ASG hangingwall**

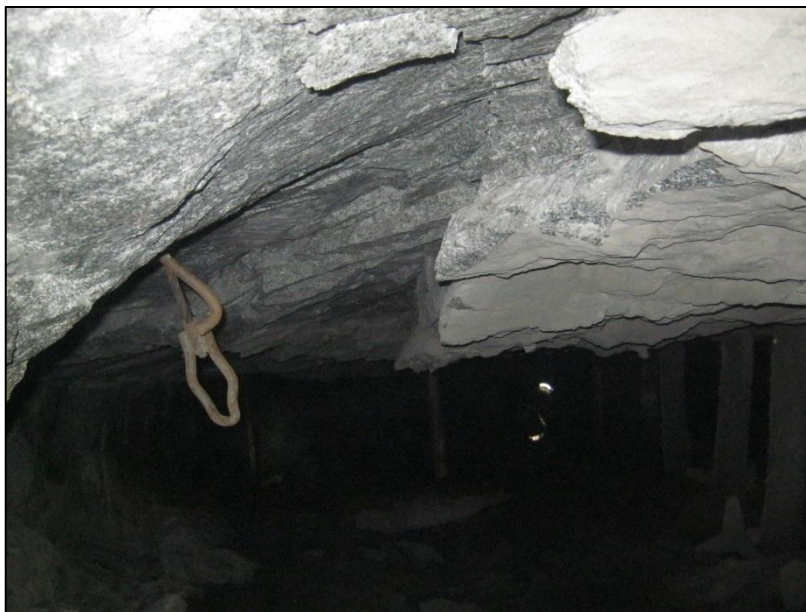
The following photograph was taken recently. Note the clearly defined fracture plane originating from the stope face.

**Figure 10: Fracture plane originating from stope face**

Considering the post blast plots the existence of consistent patterns at the primary sites indicate that once stress levels reach a certain boundary a system of load shedding is initiated. As is seen at the 29W5 site it appears that this load shedding continues even after the stope face ceases to advance. Also, the onset of such a load shedding system daylights into the excavation in the form of a sudden onset of severe fracturing of the face and immediate face area hanging wall. Figure 10 clearly illustrates the fracture surface which originates from the stope face.

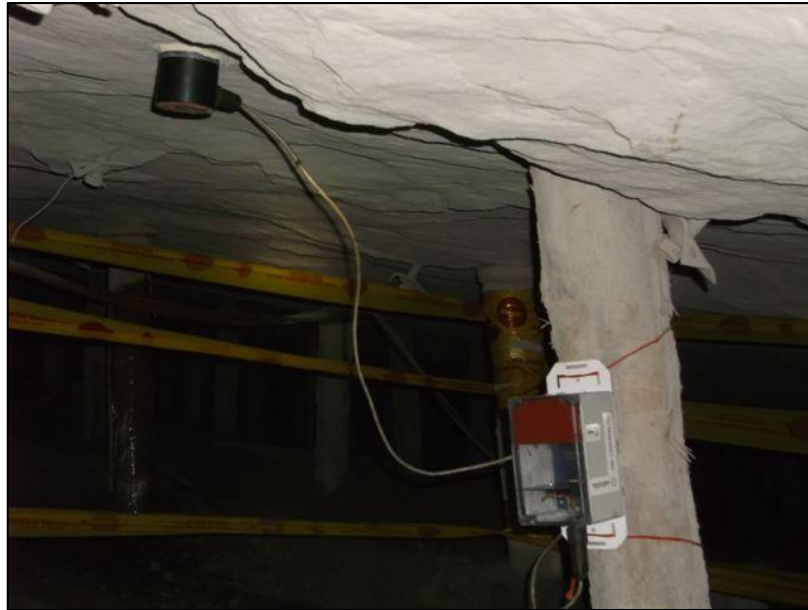
Figure 11: Installed FOGWarn unit

An instrument called a FOGWarn is available from the CSIR. This device was originally designed to provide an early warning of immanent collapse in coal mines using long wall techniques (GOAF). For this reason the instrument is extremely sensitive and is capable to record events to a magnitude of (-3.) on the Richter scale.

Each instrument has a limited detection range, typically in the order of a 50.0m radius. This will assist in ensuring that only one face is monitored by each instrument.

These instruments are easy to install: The geophone is attached to the rock face by means of a strong adhesive. No drilling is required and the system is relatively cheap.
