# Development of a Support Strategy for Cleaning Slushers Situated in Booysen's Shale at Mponeng Gold Mine

<sup>b</sup> AngloGold Ashanti Pty Ltd

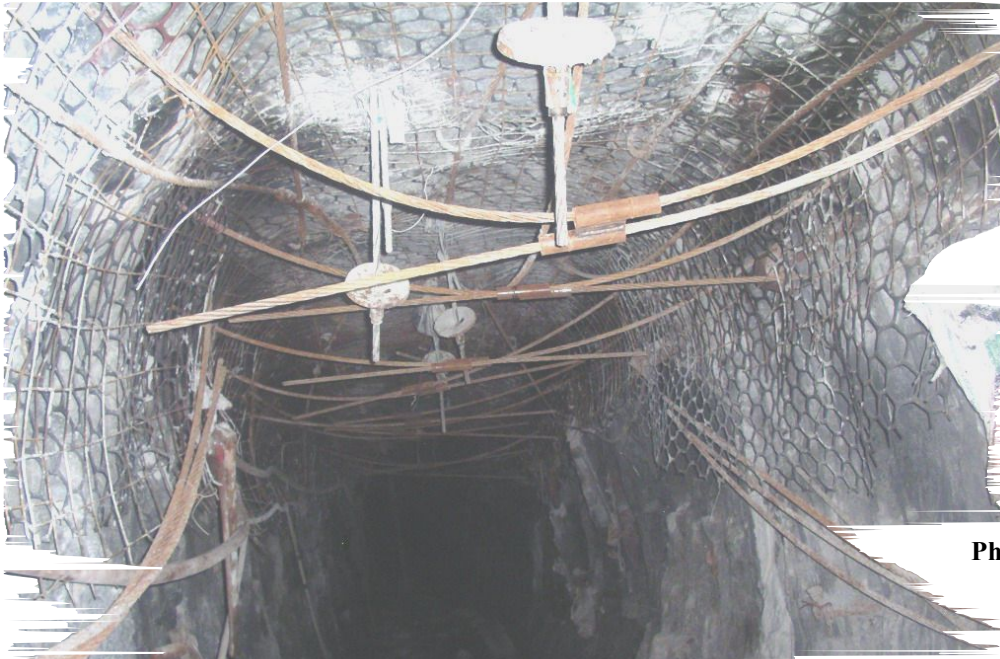
**Photo 6.**

**Photo  
showing**

**construction of the cable  
trusses spaced 1,5m apart along length of slusher, cable anchors and mesh.**

The cable anchors/trusses were installed 1,5m apart along the length of the slusher and joined with a double locking barrel. These were tensioned to 10 tons once the laggings were inserted. This support strategy is only partially successful and continued rehabilitation is required to keep these slushers open.

- Wire mesh and lace using welded mesh together with heavy duty plastic mesh against the hanging wall and 1m of the side walls. The purpose of the plastic netting is to provide long term areal coverage when the steel mesh starts to rust. The tendons used are 2,3m long, ripple bar, shepherd crooks.
- 3,5m long mechanical anchors on a 2:1 pattern spaced 1,5m apart along the length of the slusher. These anchors are pre-tensioned to 10 tons in an attempt to clamp the shale layers together thereby increasing the shear strength between individual shale layers.
- Sets consisting of trusses and wooden laggings.

Primary support was changed from 1,5m long splitsets to 1,5m long, 20mm, fully grouted bolts to limit horizontal movement between shale layers. Additional cable trusses are installed at the slusher-boxhole intersections to ensure the long-term stability thereof.

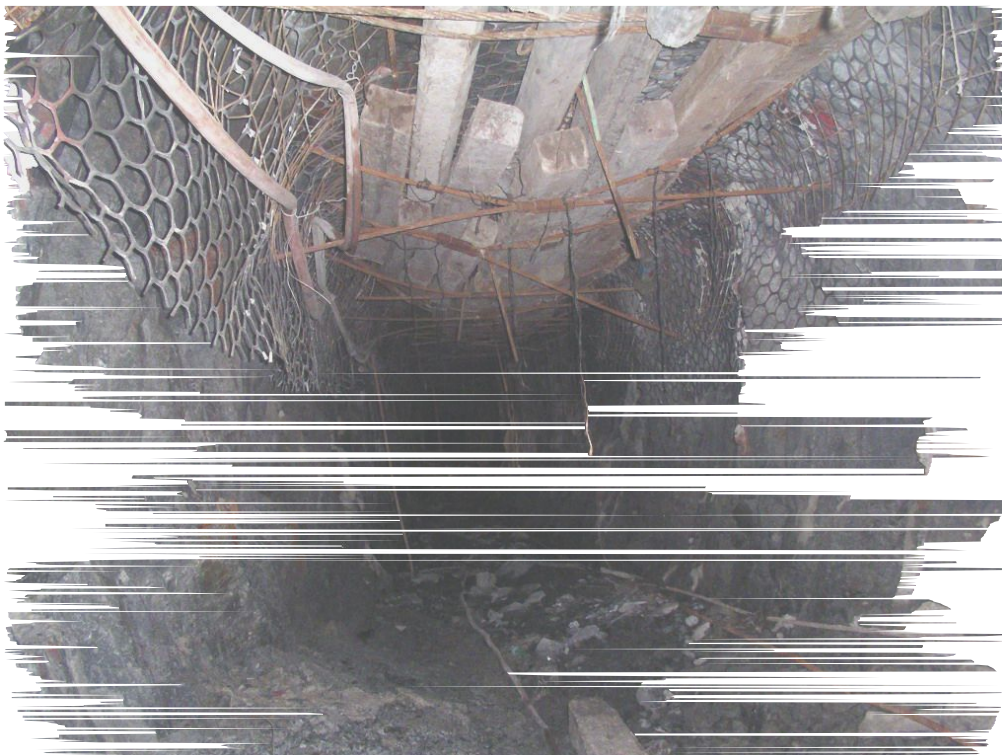
**Photo**

**7. Photo showing the complete set installation with wooden laggings.**
