# A case study on the risk of developing in the vicinity of the dolomite compartment

L.J MTEKWANA

(Masimthebe shaft) is an underground gold mining operation found in the Witwatersrand basin mining at 1900m below surface.

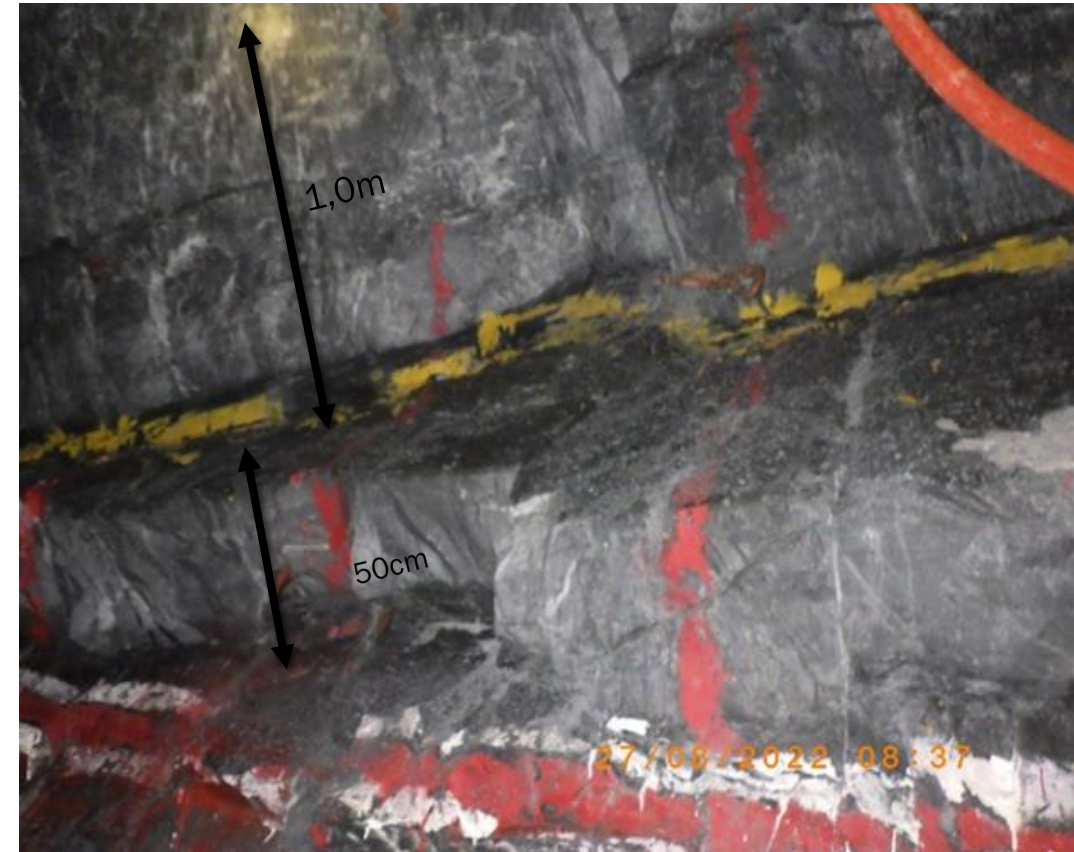
The Footwall drive

The quartzite in the FWD is greenish grey, medium grained, semi-mature and horizontally bedded dipping at 35°.

There is shale infilling on the bedding planes, resulting in weak cohesion between the beds.

The quartzite has got minor quartz veining.

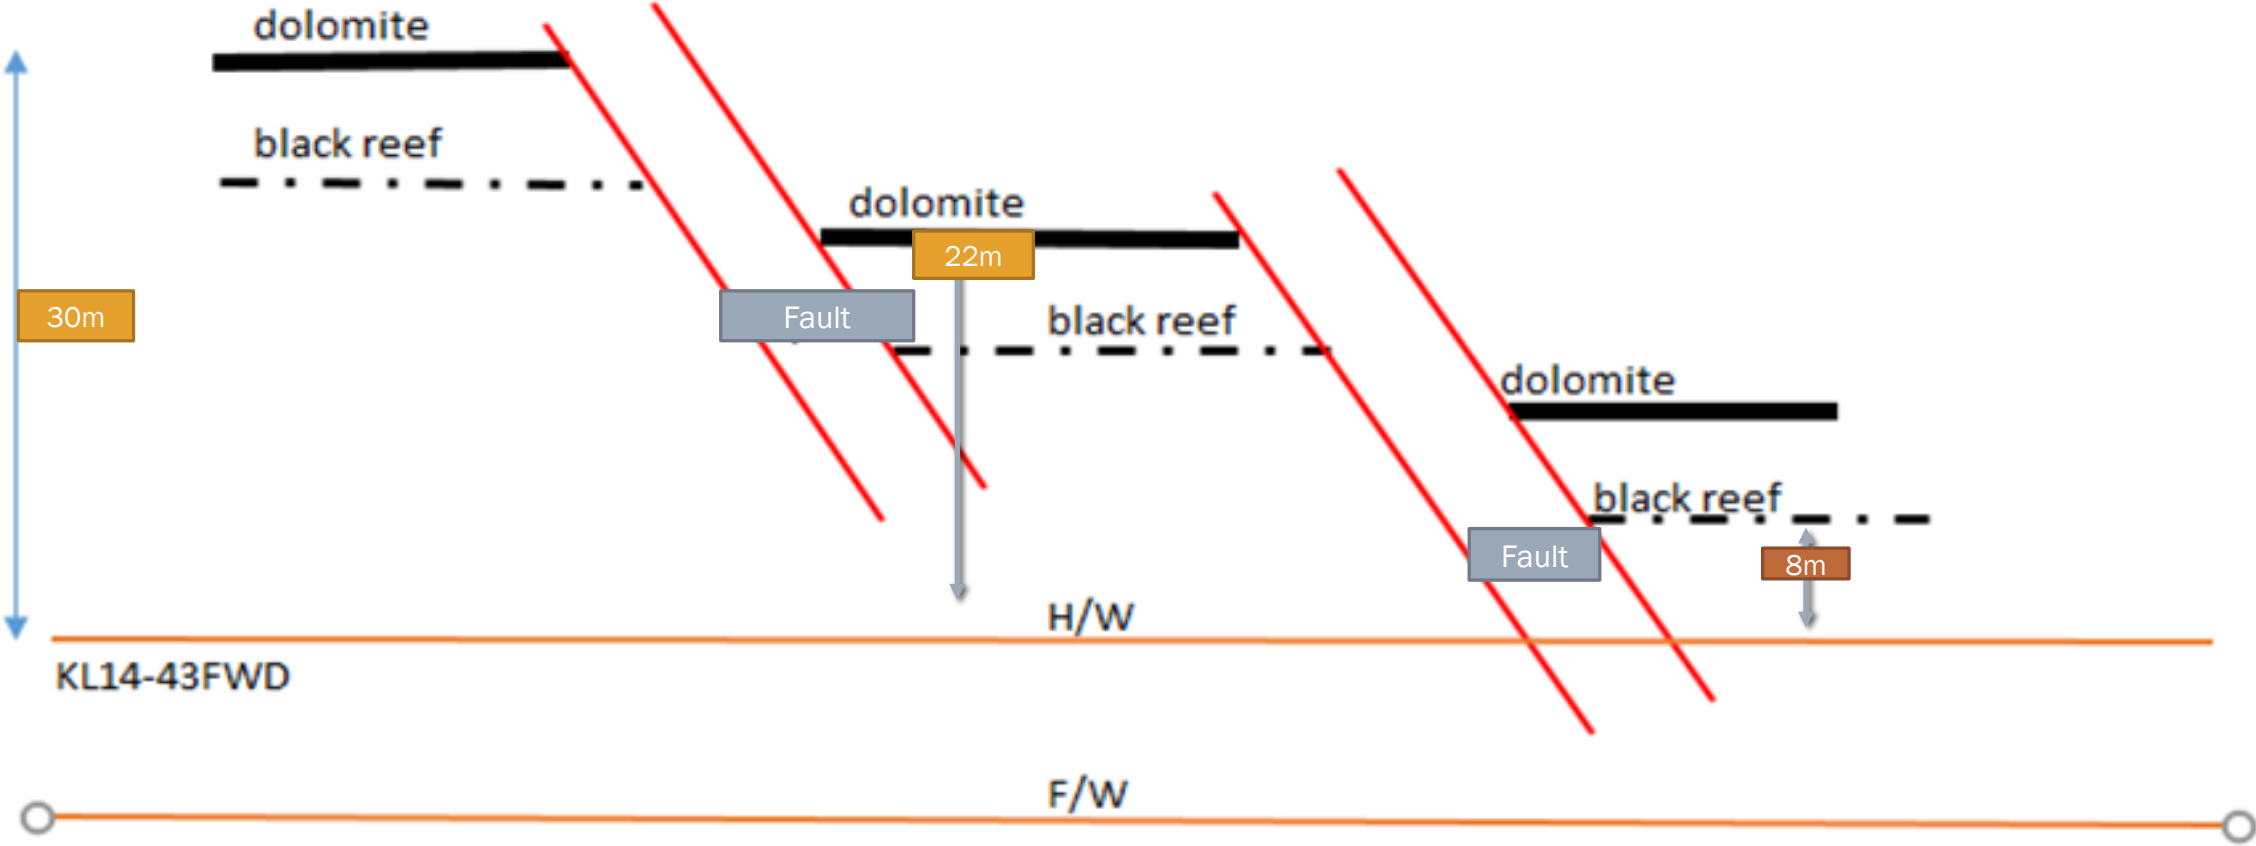
## 14 LEVEL FWD BEFORE THE STRUCTURES AND SHALES

# SECTION VIEW

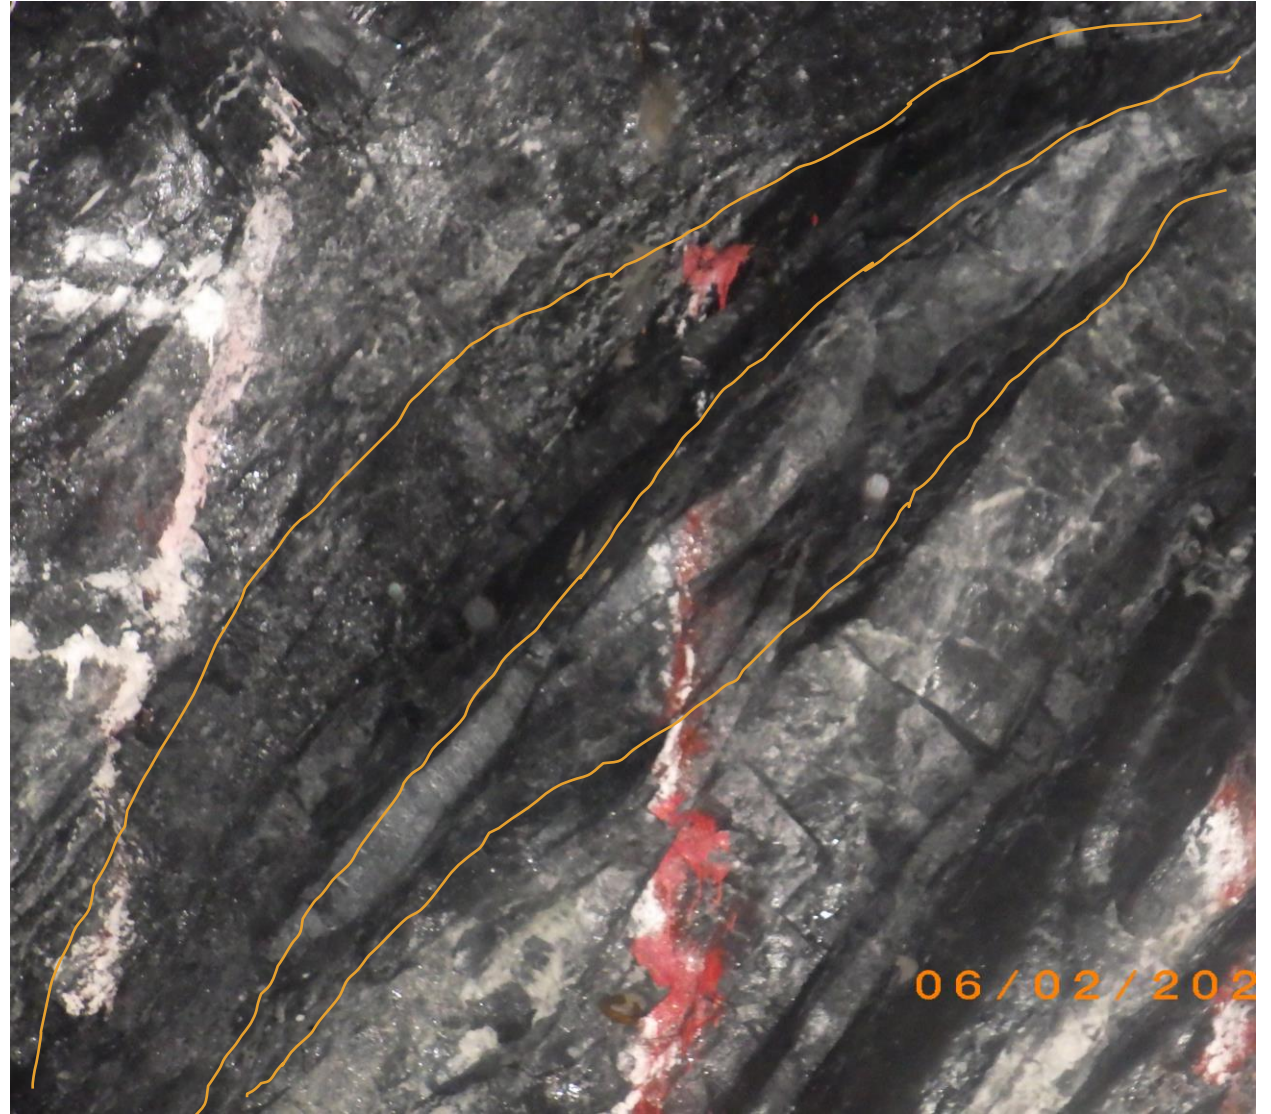
Geological  
Composition  
Overturned  
bedding planes

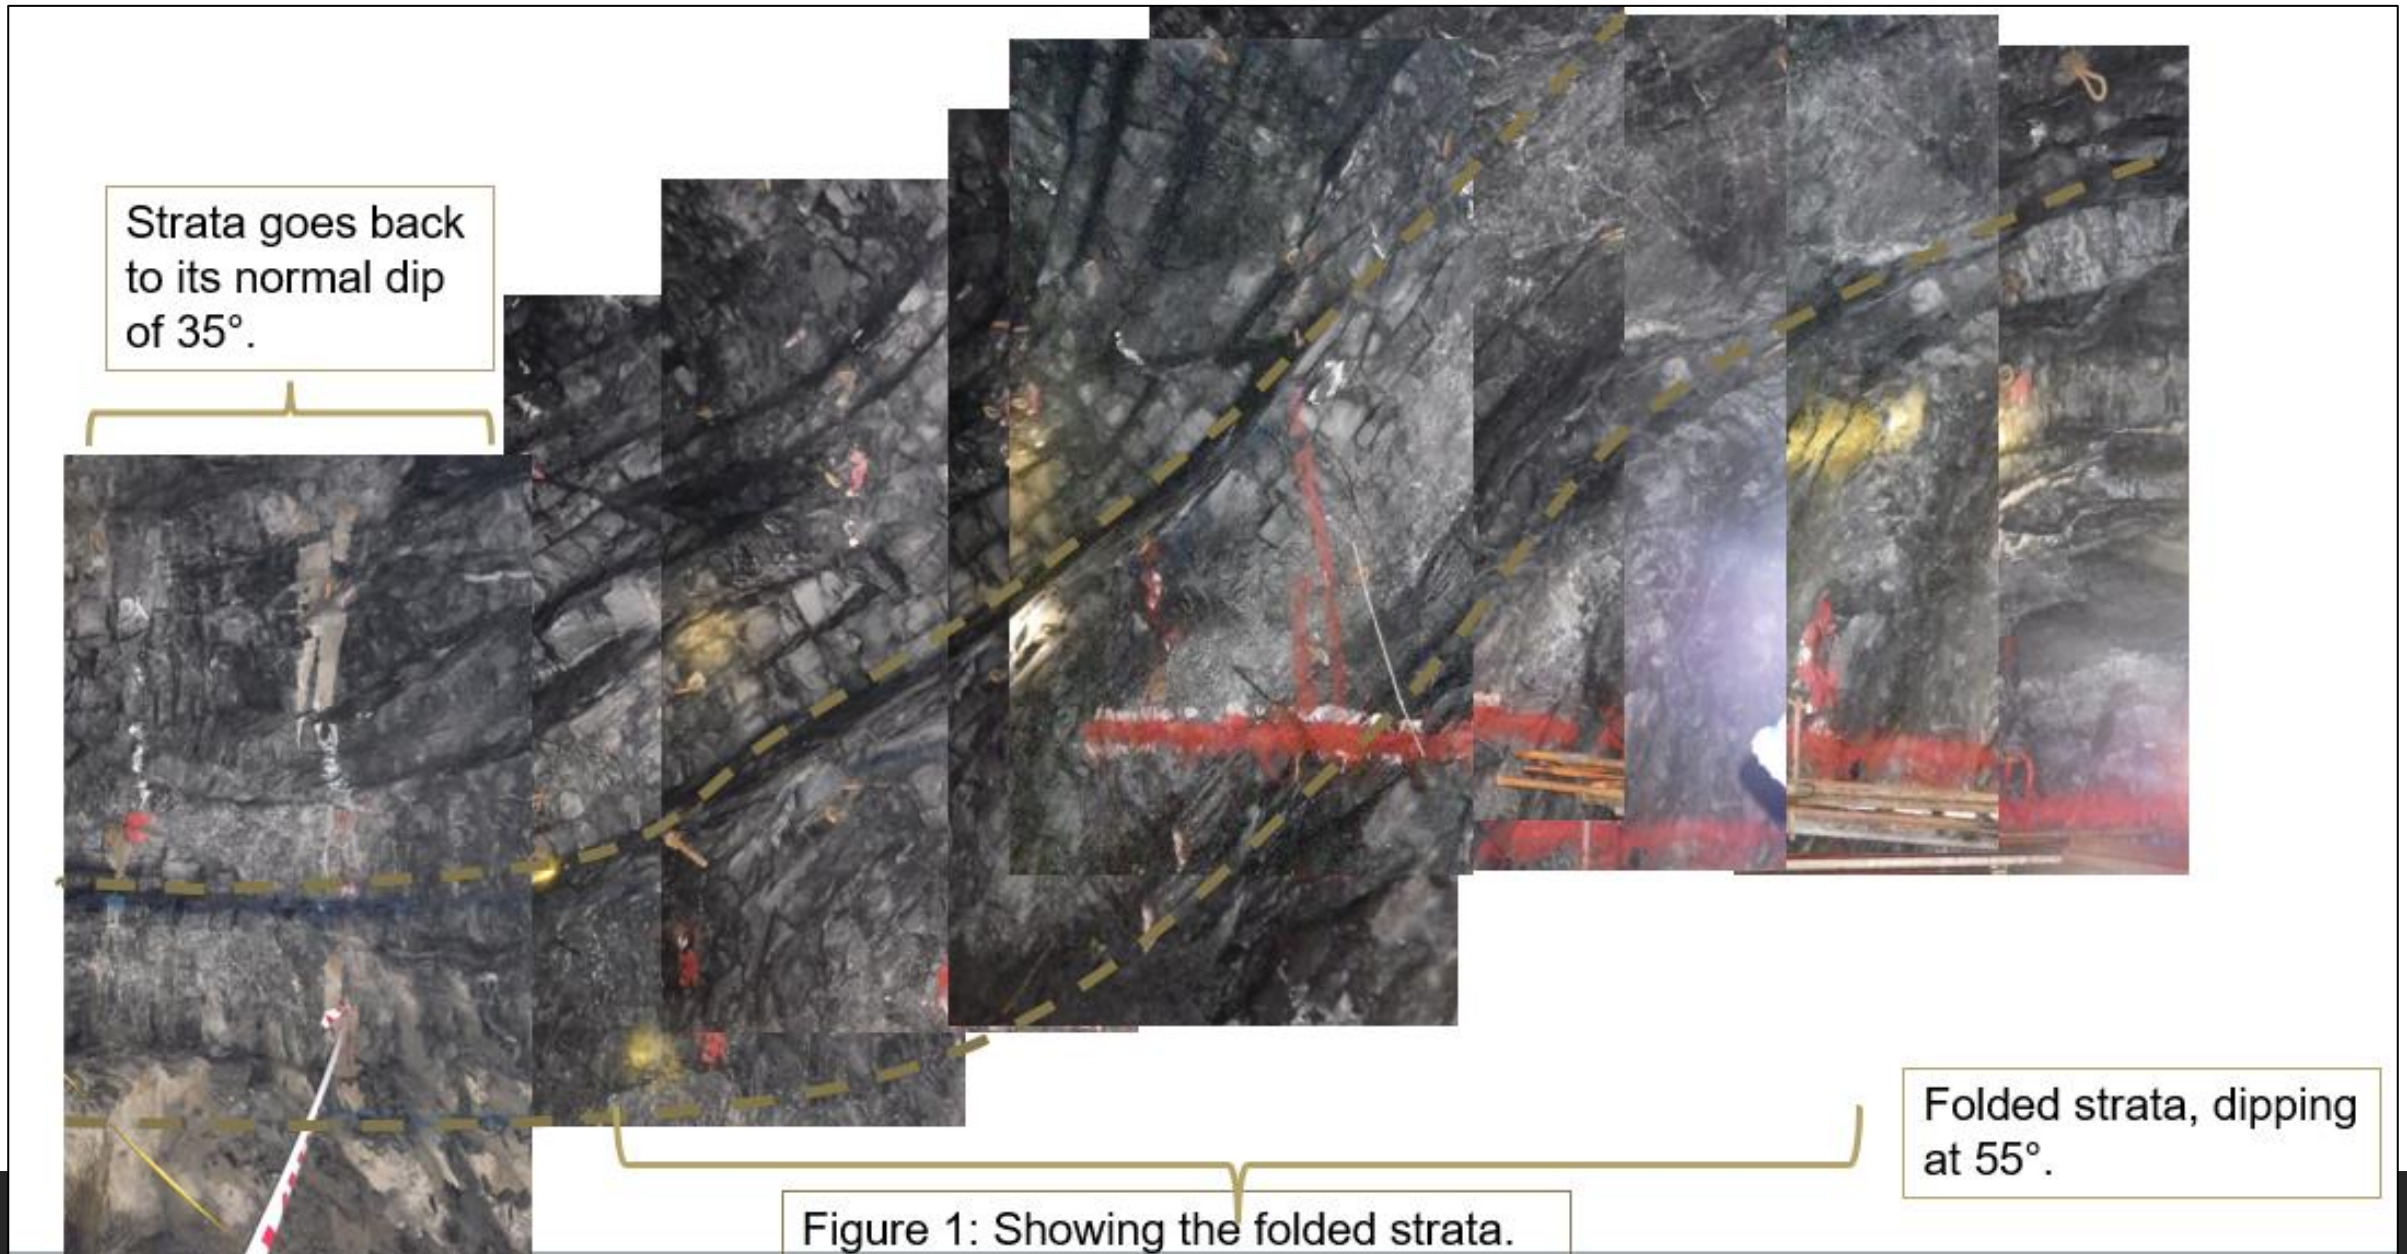
# KL14 43 FWDS SYNCLINE, INCLINE

## **Bedding planes dipping 55 degrees after the fault**

On the current face there is a fault which is dipping at 55° and striking in a NW-SE direction.

The Rock on the face and the hanging wall scale along this weak structure due to low cohesion when exposed to water.

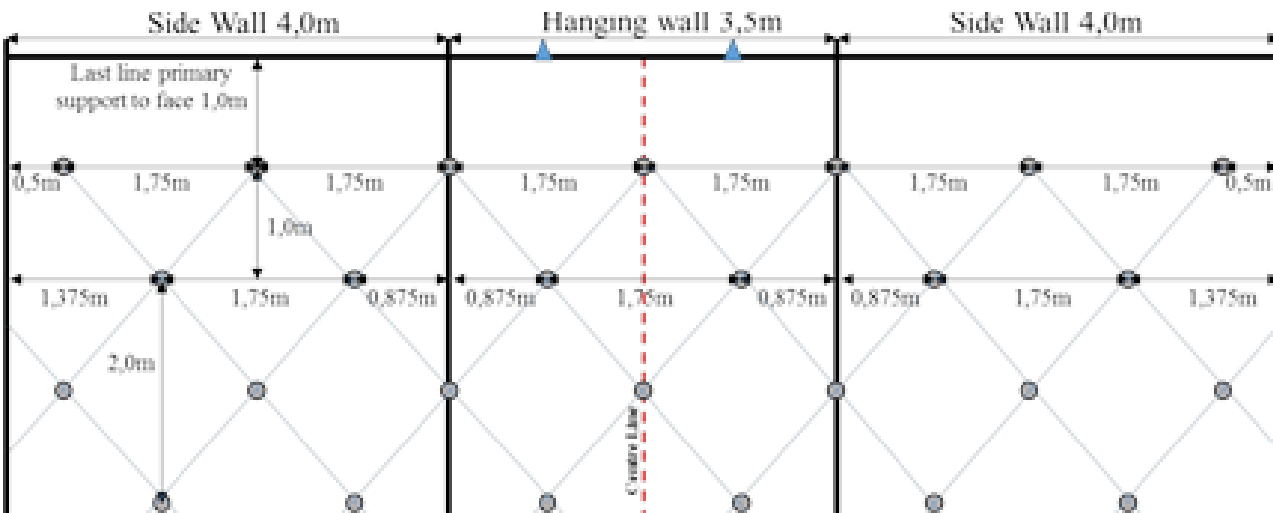
Normal Support standard

Due to the steep-dipping bedding planes new support standard was designed from {3:2:3 pattern on the hanging wall and 2:2 staggered pattern on the sidewalls to 4:3:4 pattern both hanging wall and sidewalls together with 45 degrees tendons.

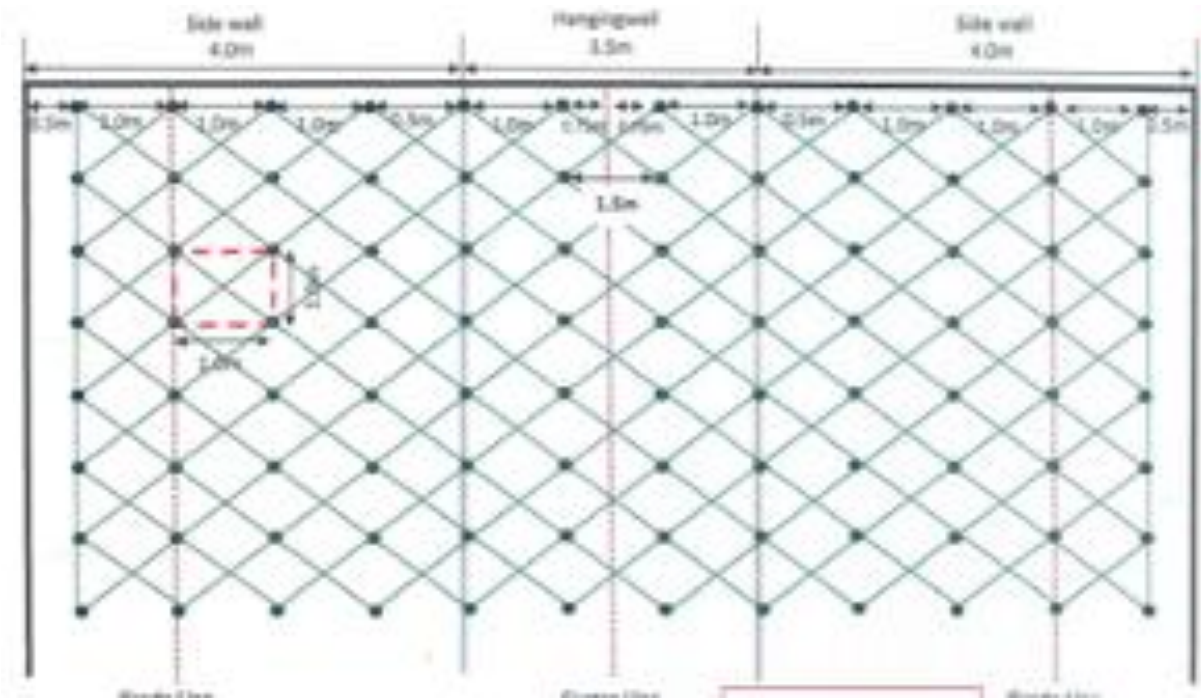
New support standard for 14 level

Wire mesh and lacing diamond shape to be more than 20m from the development end followed by Mine Crete or Gunitite.
