### 6.4.3 Empirical Design Rules

## **6.5 SPECIAL CONSIDERATIONS**

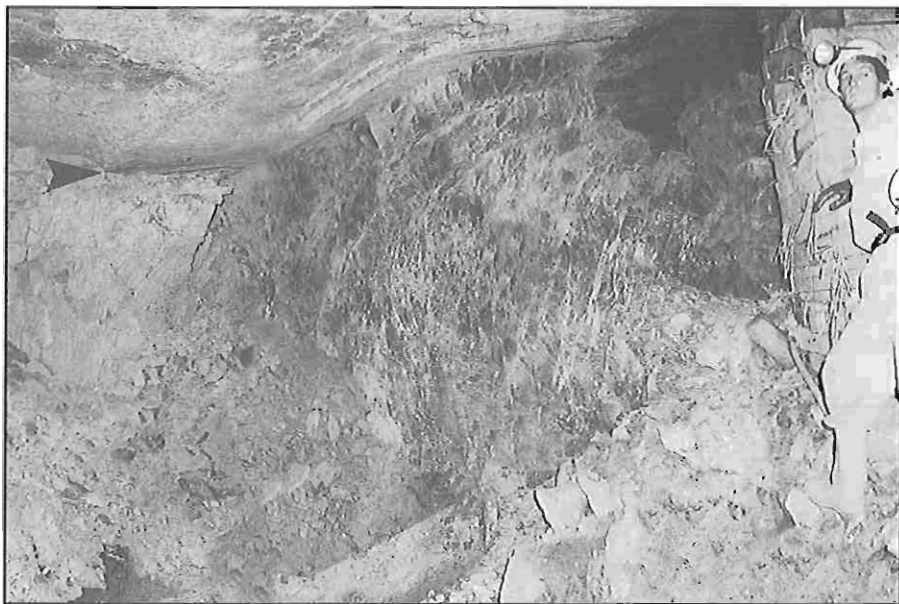
**Figure 8.3.3** Photo-mosaic showing the face, viewed from position H (Figure 8.3.1) and looking updip. The timber packs on the right are situated to the east of the roll. The corresponding section is shown in Figure 8.3.2. The hangingwall fragmented during the rockburst. Most of the fallen rock was subsequently removed. Note the numerous fractures and joints in the face, and the smooth surface marking the parting above the collapsed brow.

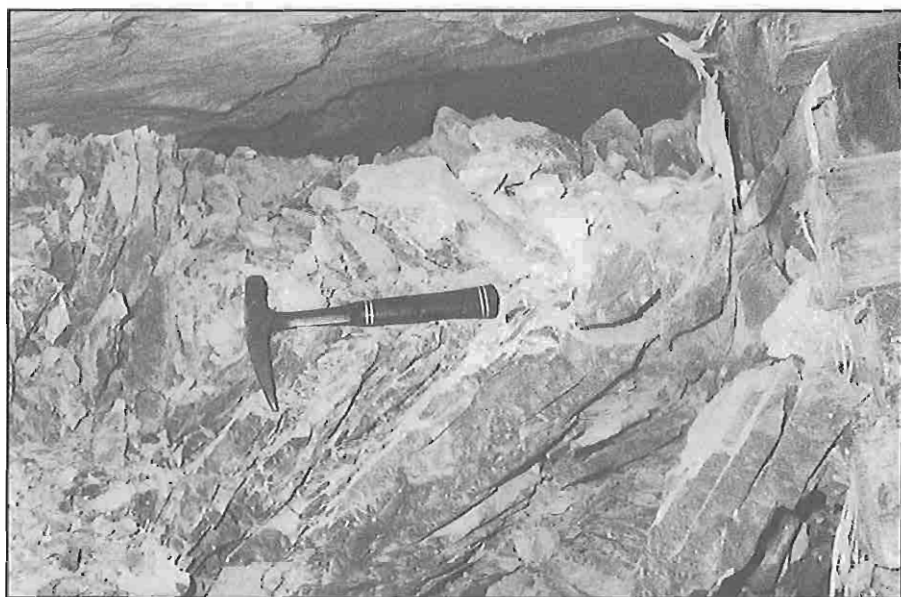
**Figure 8.3.4** Rock ejected from the footwall and face between F and G (see Figure 8.3.1) into the space between the original face position and the first dip line of packs. The photograph is taken looking updip with the face to the left. Note the intact hangingwall.

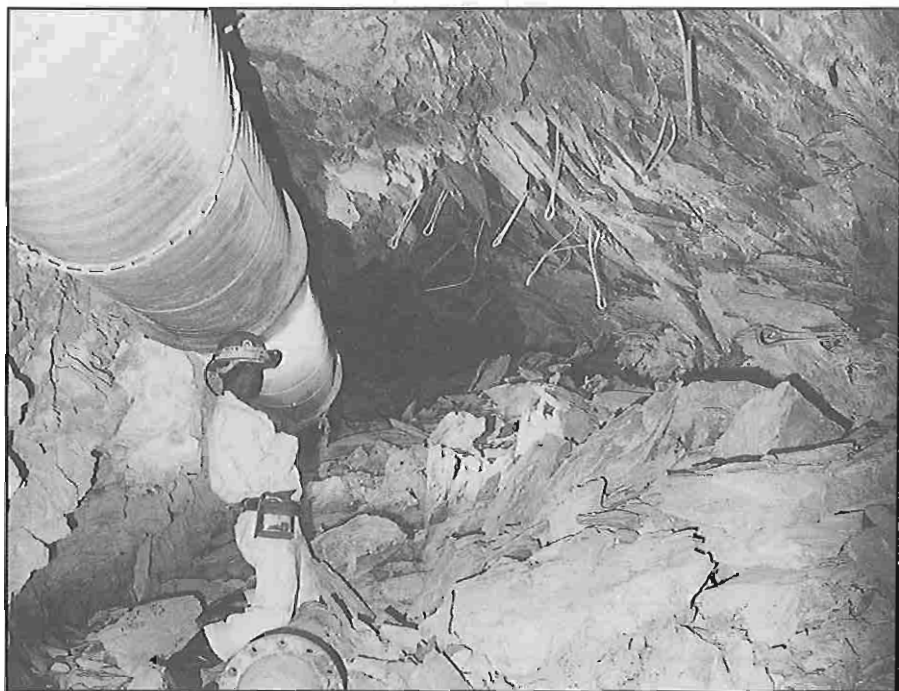
The damage on 34 and 35 Levels was generally associated with the north-eastern sidewall and the hangingwall of the excavation where the tunnel was oriented in a south-easterly direction, i.e. parallel to the local strike. A key factor controlling the distribution of the damage was the type of support in place at the time of the rockburst. Some sections were supported by grouted rebars, mesh, lacing and shotcrete, and suffered little damage. Other sections, where mesh and lacing had not yet been installed, sustained severe damage. In a tramming loop east of the shaft, the southern sidewall was severely damaged for a short distance where the loop approached the main development (Figure 8.3.6). A section of another footwall drive (site B) was completely blocked by the bulking of the sidewall (Figure 8.3.7). Footwall heave from a north-easterly direction was also evident in the footwall drives in almost all places where damage was noted. In a 34 level cross-cut, damage was confined to a 20-30 m long section where bad rock conditions had been encountered in the past. In this area both sidewalls were damaged, and footwall heave

**Figure 8.3.6** Damage to 34K footwall drive at Site A showing falls of ground between grouted shepherd's crook tendons. Mesh and lacing had not yet been installed in this section of the tunnel. In this area, the south-western (right hand) side of the drive was most severely damaged.

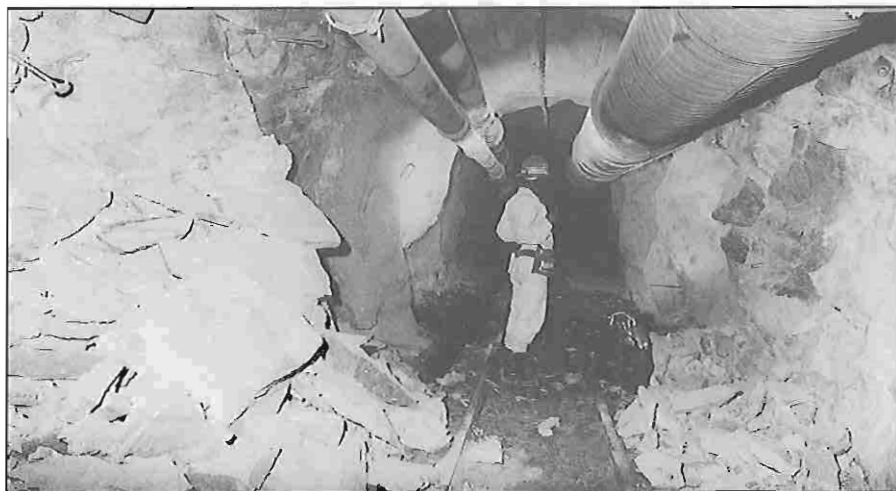
vent collapse. Both shear and tensile modes of failure of the rebar support occurred within the meshed and laced areas of the tunnels, but the system integrity was largely maintained. However, should the excavations be subjected to further seismic loading, total failure of the system could well occur.

**Figure 8.3.8** A haulage on 34 level showing the effect of the support system on damage. The section of the tunnel in the foreground was supported only by grouted rebars, and significant damage was sustained. The support system in the section of the tunnel beyond the miner consisted of grouted rebars, mesh, lacing and shotcrete. Damage was negligible.
