# Back Analysis of Rockburst Damage To Verify Assumed Design Parameters

Lucille Cilliers & Koos Bosman

# Buffelsfontein Gold Mine

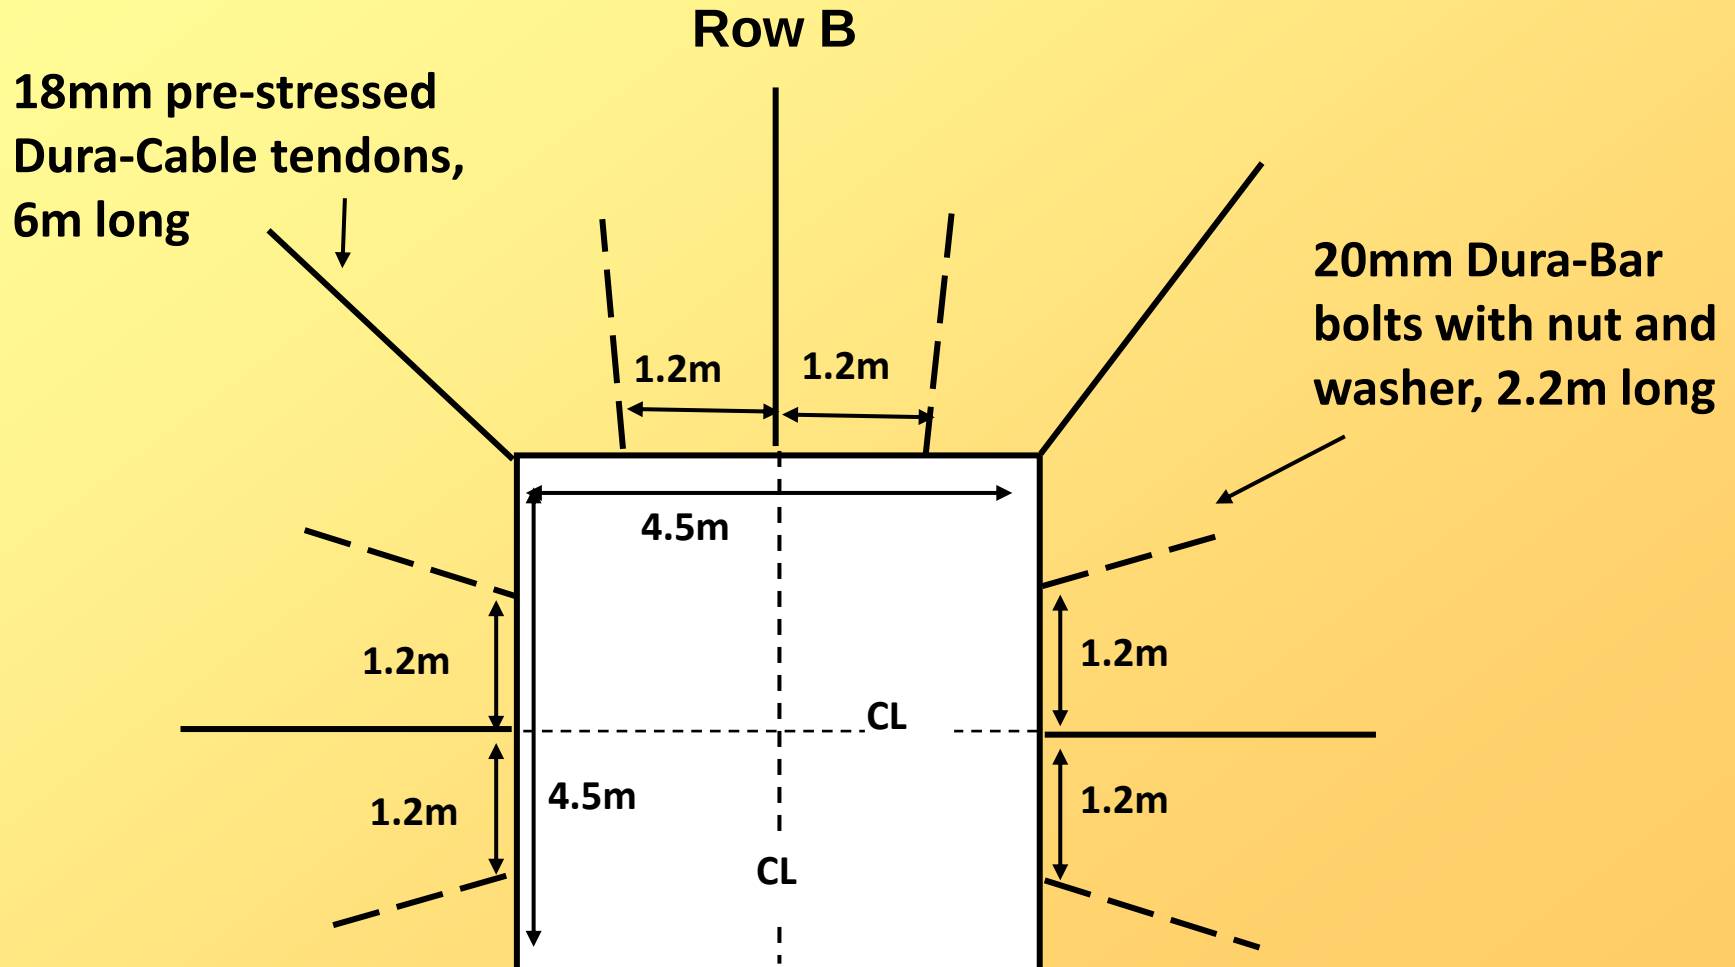
# Support pattern

- With 11 x Durabars and 11 x Duracables in a tributary area of  $27\text{m}^2$
- Durabar =  $190\text{kN}$  and  $35.61\text{kJ}$
- Duracable =  $270\text{kN}$  and  $100.91\text{kJ}$
- Support Resistance =  $187\text{kN/m}^2$
- Energy absorption =  $55.61\text{kJ/m}^2$

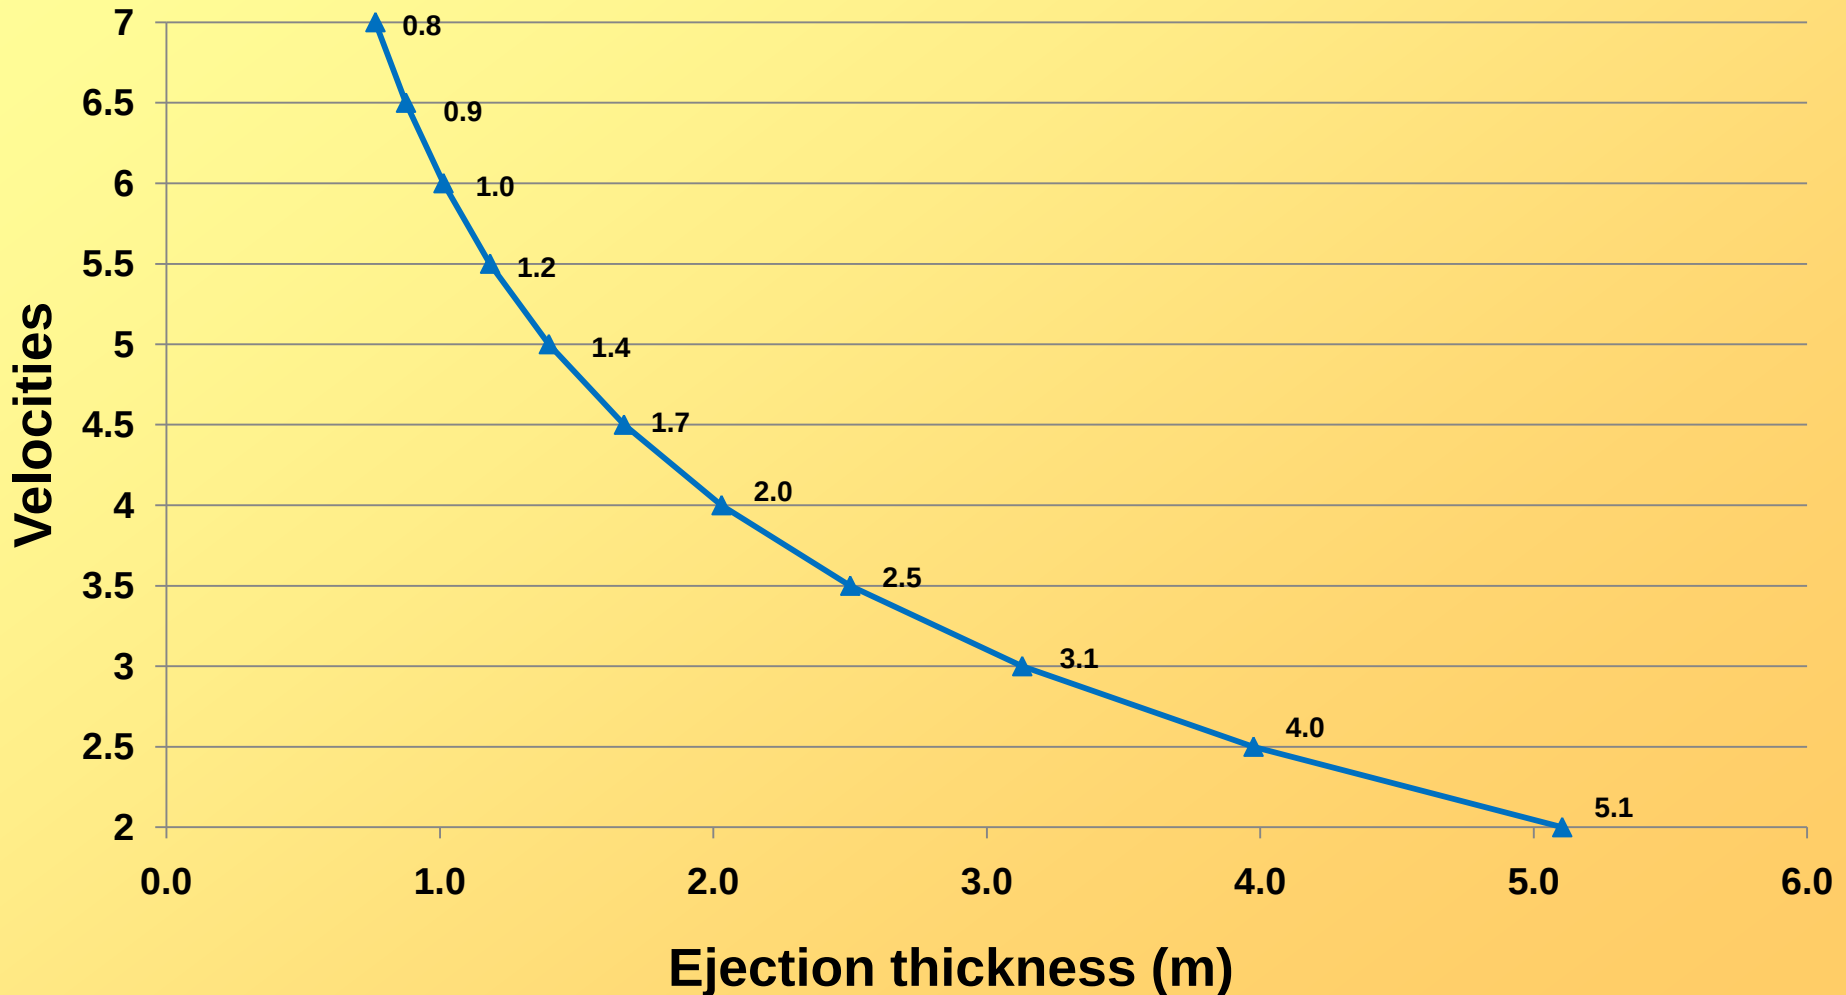
# Potential Ejection Thickness

Velocities vs Ejection thickness
